## GEOTECHNICAL STUDY AREA G10

### AFTON DOWN, NEAR FRESHWATER, ISLE OF WIGHT, UK

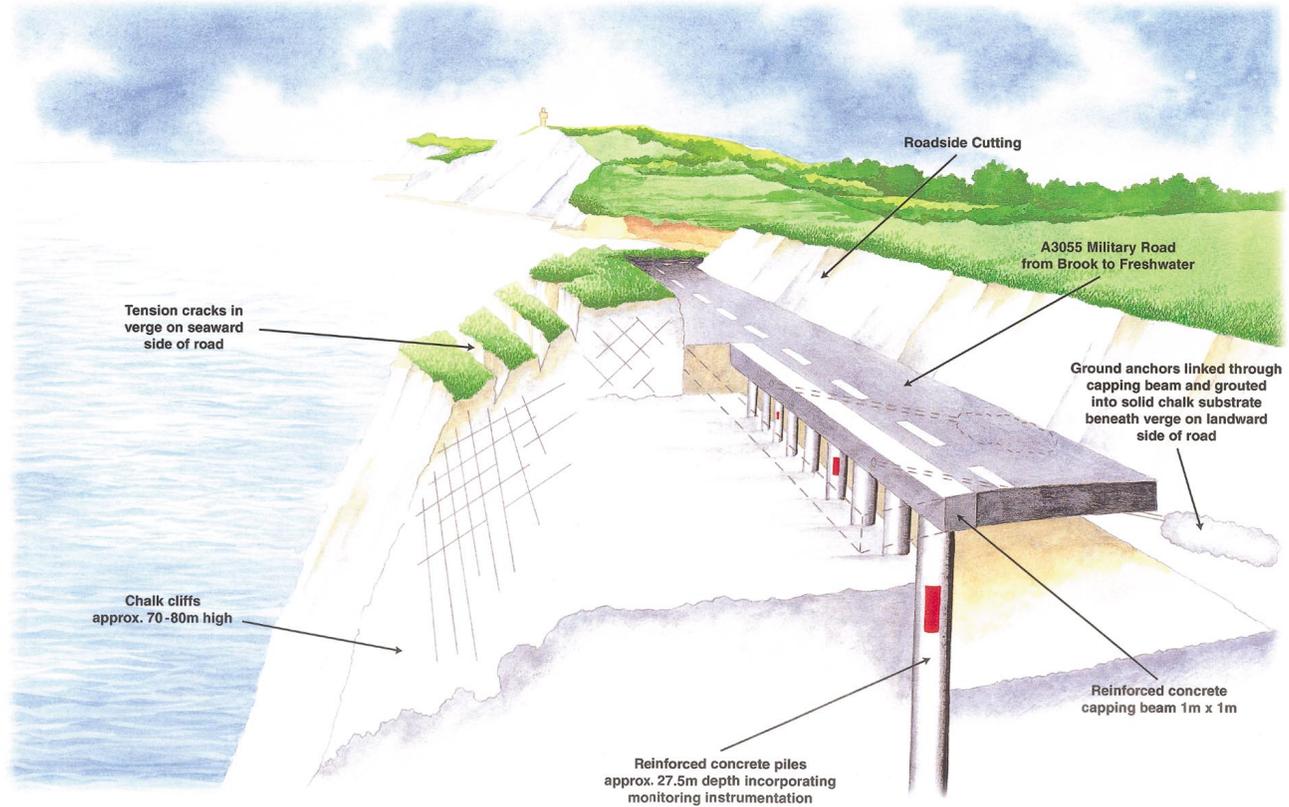
Figure G10.3 The proposed stabilization scheme.

Government funding has been approved for a £2m stabilization project for the most vulnerable section of the A3055 Military Road over Afton Down and will comprise civil engineering works that provide continuous protection in the inevitable event of future cliff recession and will consist of an anchored contiguous bored pile wall supporting a reinforced concrete deck for the carriageway. The piles conceptually will be sunk 27.5m into the Chalk beneath the centre line of the existing road over a length of 2-300m. The piles would be linked to the reinforced concrete road-deck and provision made for ground anchors into the stable hillside on the landward side of the road. The bedding orientation in the area of the anchors is low and favourable and a preliminary scheme concept is attached as Figure G10.3.

The benefits of a scheme of this kind is that the natural processes of cliff recession can continue to take place due to coastal erosion but the construction will remain unaffected. As the cliffline recedes in the longer term to approach the carriageway, a protective road edge barrier would be provided adjacent to the carriageway edge at this location. Furthermore, natural erosion could take place beneath the reinforced concrete carriageway deck itself until the face of the bored pile wall is reached. This would halt erosion over a fairly limited length of the road for a further period of 30-40 years, giving an overall life for the structure of approximately 60 years.

The Council has now obtained planning consent to carry out highway stabilization works at Afton Down on the Military Road (Figure G10.3). It is expected that work will commence in the spring 2001. A key part of the Council's strategy for management of this part of the coastline will be on-going monitoring, which will be much aided by the improved equipment installed at this location in 1998.

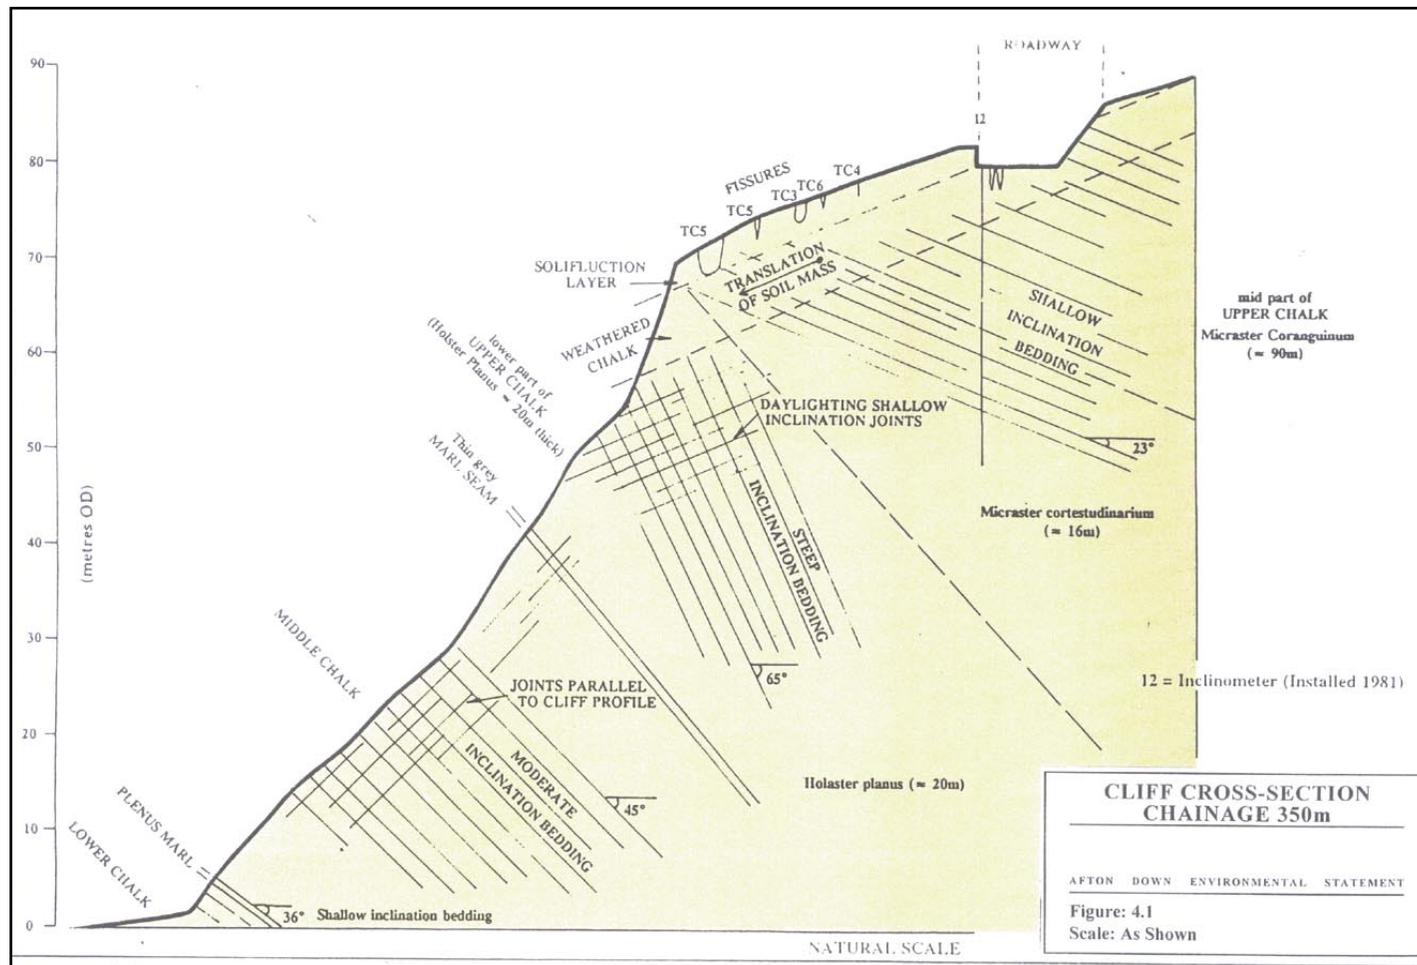
Figure G10.4 Cross section through the Afton Down cliff.

Within the study area the geology comprises Lower Chalk, which is exposed in the lower section of the coastal cliff down to beach level. This is overlain by Middle Chalk with marl seams and Upper Chalk at the top of the cliff. The solid geology is overlain by a layer of weathered Chalk (0.5-7m thick) and an irregular cover of chalky head of Pleistocene periglacial origin (0.5-2m thick). A description of the lithology of the full stratigraphic sequence is presented in Figure G10.2 and Figure G10.4 shows the general cross-section of the cliff.

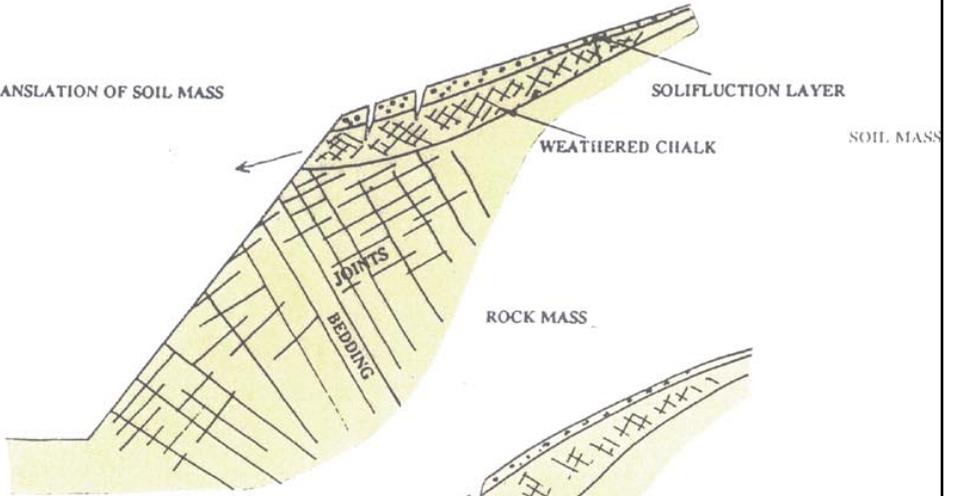
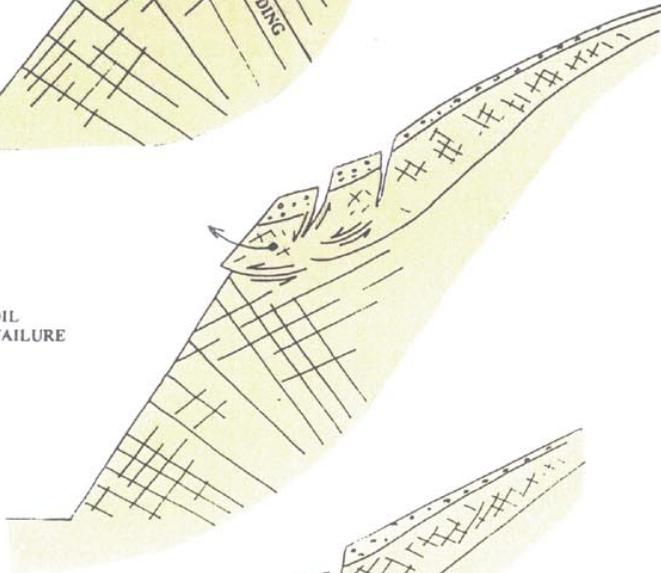
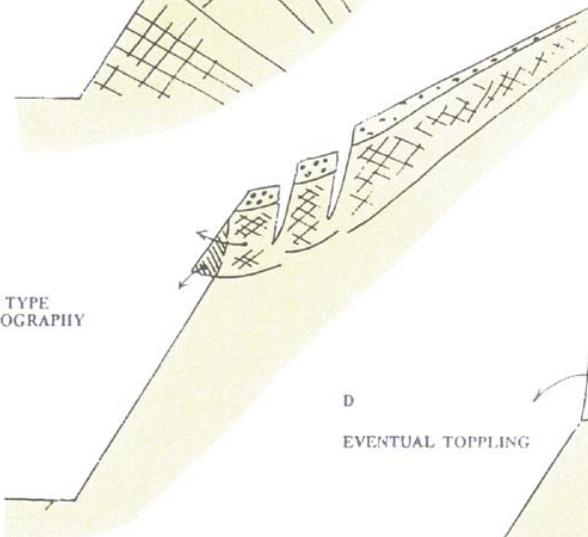
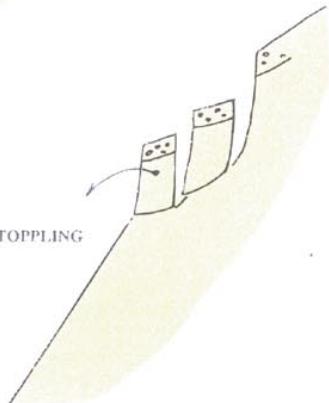
Figure G10.5 Cliff failure mechanisms.

There are two modes of failure in the Afton Down cliffs, one of which is specific to the layer of soil mass at the top of the cliff and the other to the rock mass comprising the bulk of the cliff (Figure G10.5). The soil mass layer is composed of a solifluction layer and weathered Chalk, whilst the rock mass comprises blocky Chalk. The geology is specific to the site and changes beyond both the east and western boundaries.

The first scenario involves the greater movement of the two cases. Here, translation of the soil mass coincides with rock mass failure and the resulting undercutting leads to a toppling failure.

Fissuring allows toppling blocks of soil mass to form, which produces a steepened cliff top profile near the cliff edge. The ground space remaining upslope may allow limited circular failure to occur so that flat or back tilted plateau areas are formed along with a lesser series of fissures.

A second scenario involves undercutting of the soil mass by failure of the rock mass and is not as significant as outlined above with the amount of movement being more limited. This allows limited circular failures to occur in the translational soil mass. Eventually erosion produces a narrow column at the cliff edge, which then fails by toppling.

TRANSLATION OF SOIL MASS

CIRCULAR SOIL MASS FAILURE

CATEGORY 2 TYPE FISSURE TOPOGRAPHY

EVENTUAL TOPPLING

CIRCULAR FAILURE FOLLOWED BY TOPPLING FAILURE INVOLVING RELATIVELY LIMITED GROUND MOVEMENT

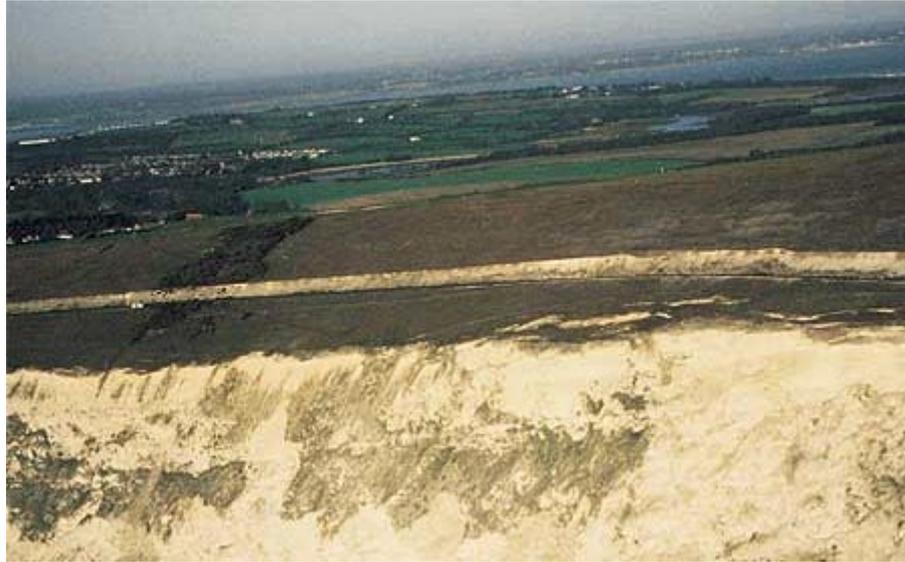
**Plate G10a** *High aerial view of the Military road over Afton Down showing fissures*

Since the 1970s particular sections of the Military Road have been under threat of coastal instability as a result of marine erosion at the base of the unprotected cliff which leads to cliff failure and cliff top recession. Four high risk areas were identified as part of a previous study and one of these areas has become increasingly at risk since that time (Plate G10a).

The location of concern is sited approximately 1.5km east of Freshwater Bay at Afton Down. It comprises a steep chalk cliff approximately 70m in elevation above sea-level. The Military Road is located along the top of the cliff at distances between 10 and 45m from the present cliff edge over the critical section. The slopes forming the top of the cliff are traversed by a

series of fissures which are, typically in the order of 20 to 40m in length, observable depths of up to 4m and up to 5m in width at the ground surface. The fissures were also observed beneath the road during closure and repair to the carriageway undertaken by the Isle of Wight County Council in 1980/81.

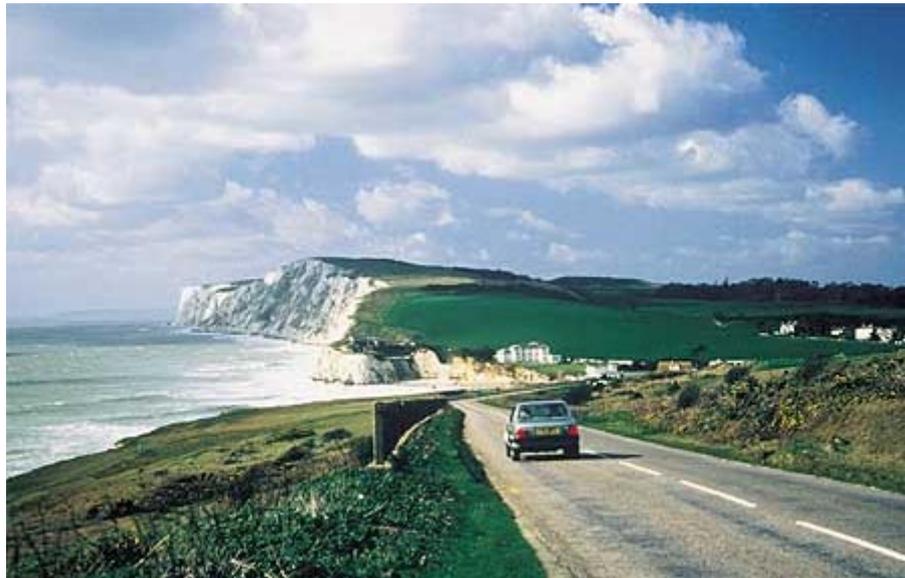
**Plate G10b** *The Military road looking west*

The length of A3055 Military Road between Brook and Freshwater forms the most spectacular part of the round the Island route. The Military Road improvement was an ambitious construction project for the Isle of Wight County Council when a south coast marine drive was created in the 1930s following the transfer of the highway to the Local Authority. Quite apart from the value of the road as a communications link between some of the Island's major tourist attractions, towns and villages along the southern coast of the Island and Freshwater Bay and Alum Bay, it forms a vital part of the round the Island coach traffic route (Plates G10b and G10c).
