GEOTECHNICAL STUDY AREA G3

BONCHURCH LANDSLIDE, VENTNOR UNDERCLIFF, ISLE OF WIGHT, UK

Plate G3 Bonchurch landslide, February 1995, Isle Of Wight , UK

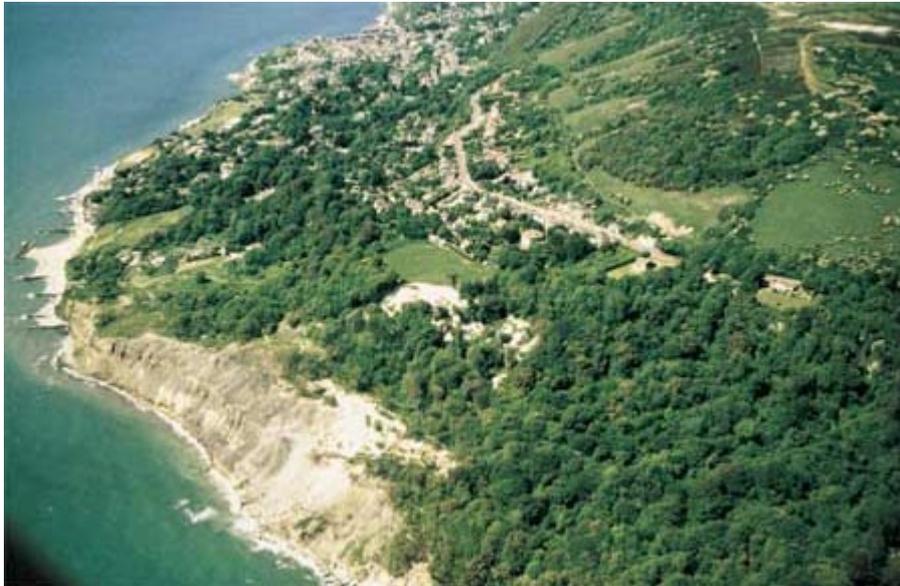
In early February 1995 a large landslide was reported to have occurred in the area known as “The Landslip”, which is situated on the south coast of the Isle of Wight at Bonchurch to the east of Ventnor (see Plate G3 and Figure G3.1). The Landslip area was owned by the Local Authority who first reported the incident to its consulting engineers on 6th February 1995.

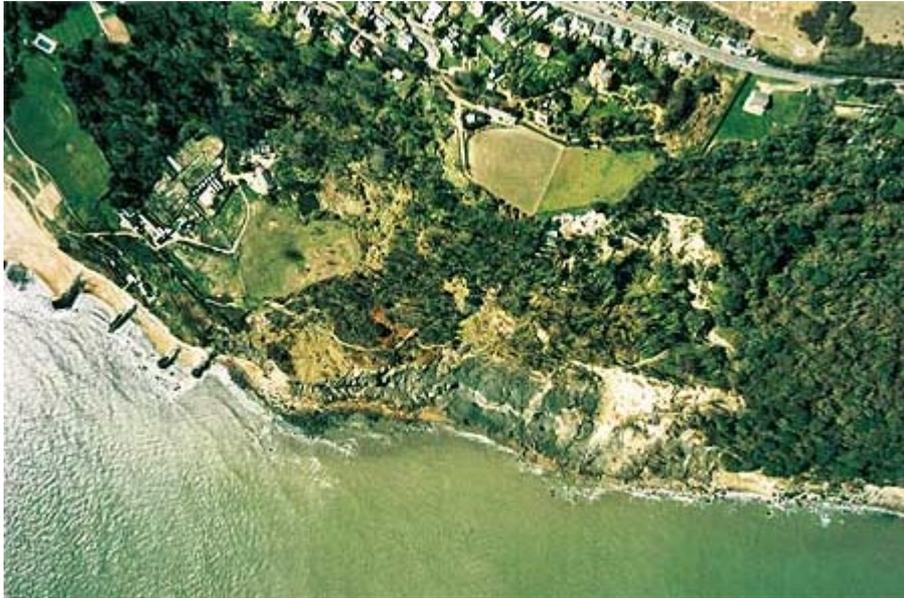
Plate G3a *Damage area arising from the 1995 landslide*

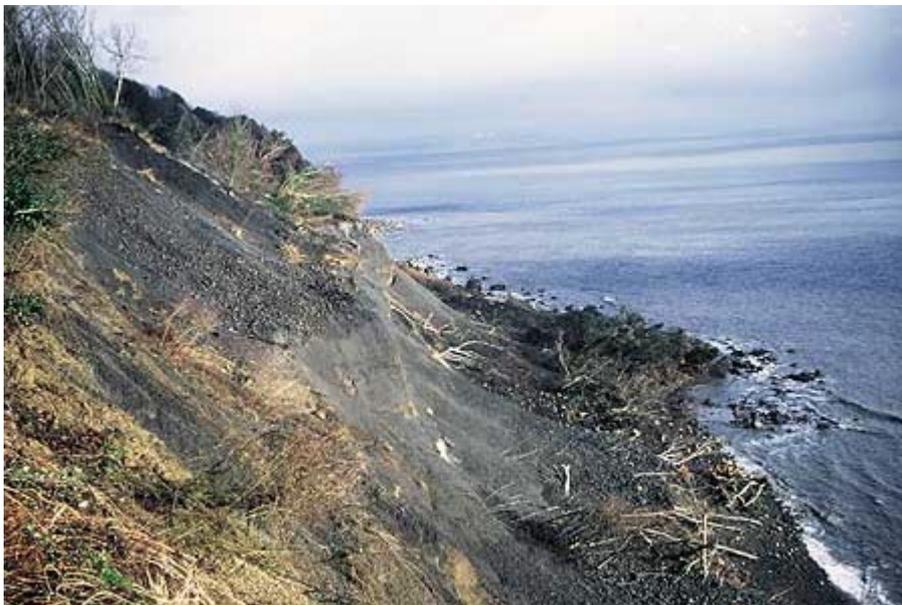
The extent and scale of the landslide led to widespread damage mainly within The Landslip itself but with minor slope instability in adjacent areas. However, the landslide also had an impact on adjacent areas, the most notable being the deposition and run-out of debris on the foreshore and the localised collapse of the rear scarp. The latter led to the loss of private land used for grazing above the rear scarp of The Landslip. The retreat of the scarp occurred through several cliff falls at the time and subsequent to the initial landslide event.

Plate G3b *Landslide debris covers the sea, cliff and foreshore*

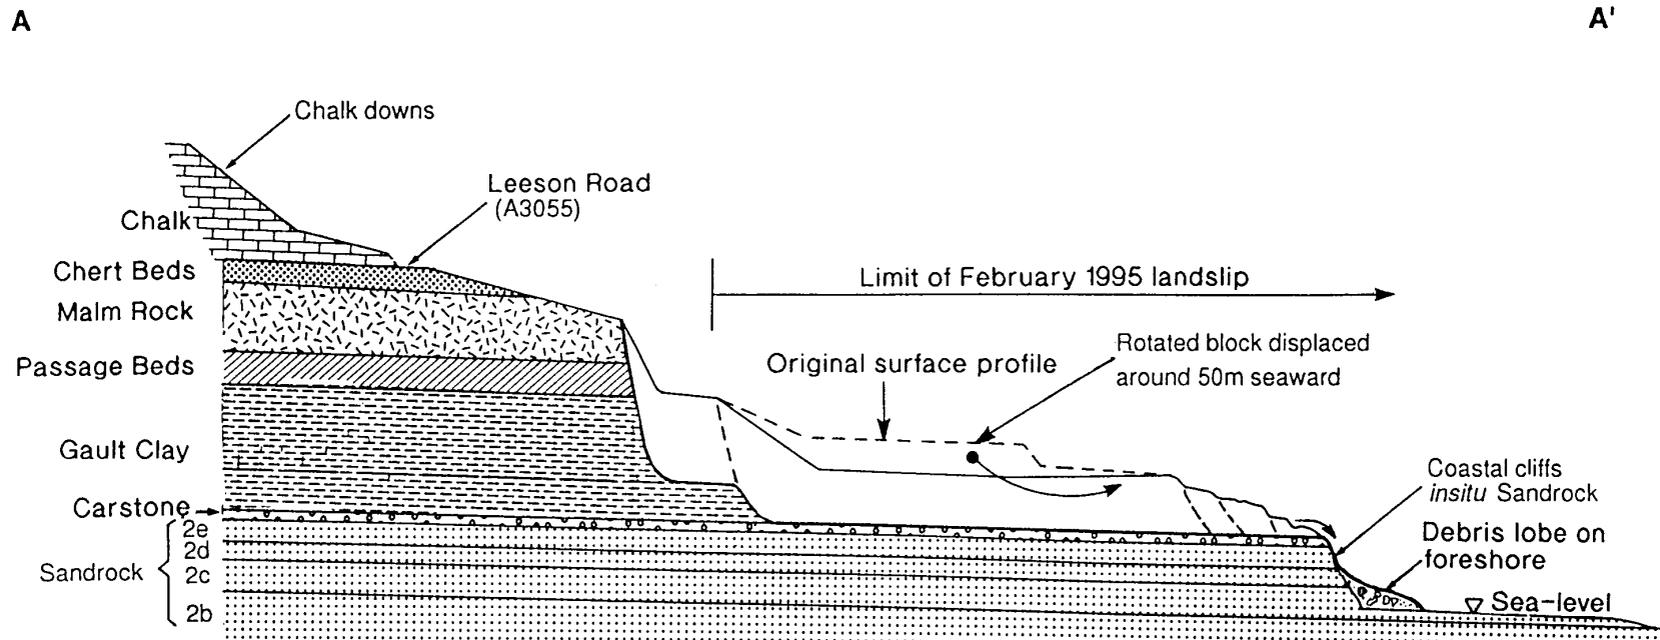
Figure G3.2 Geological cross section through the Bonchurch landslide.

The geological structure of the Southern Downs has had a significant influence on the hydrogeology and stability of the coastal slopes (see Figure G3.2). The horizontally bedded strata of the downs dip gently to the south at 1-2° (White 1921). A shallow syncline is present within the Undercliff, the axis of which plunges gently to the south-south-east in the vicinity of Ventnor (Hutchinson 1995; Chandler 1984). The Landslip is situated on the eastern limb of the syncline, whereby the elevation of strata increases to the east which gives rise to a marked coastwise dip in the strata to the south-west.

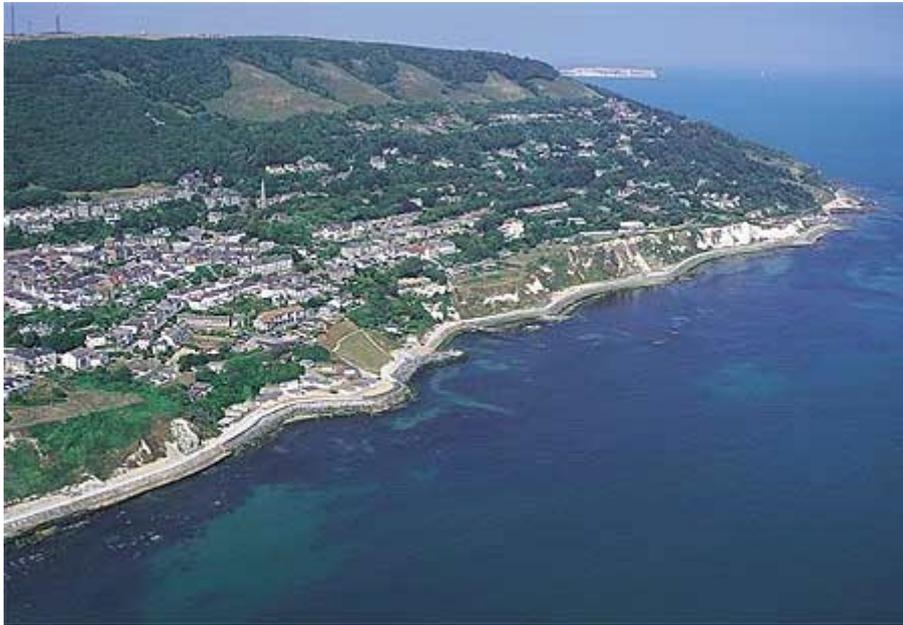
Of greater concern was the potential extension of land instability northwards towards properties and the A3055 Shanklin-Ventnor road situated upslope of The Landslip (Plate G3c). It was considered that the built development and main road were not immediately at risk from the landslide due to the fact that the instability was largely confined to within The Landslip and that the development is set back at least 90m from the nearest instability. However, the resultant unloading of slopes within The Landslip adjacent to the boundaries of the landslide, will have undoubtedly caused a decline in stability in these areas. There is significant potential for the extension of landslide activity upslope, particularly along the northern boundary, which is at a

Plate G3c *Bonchurch from the sea*
