GEOTECHNICAL STUDY AREA G5

WHEELERS BAY, VENTNOR UNDERCLIFF, ISLE OF WIGHT, UK

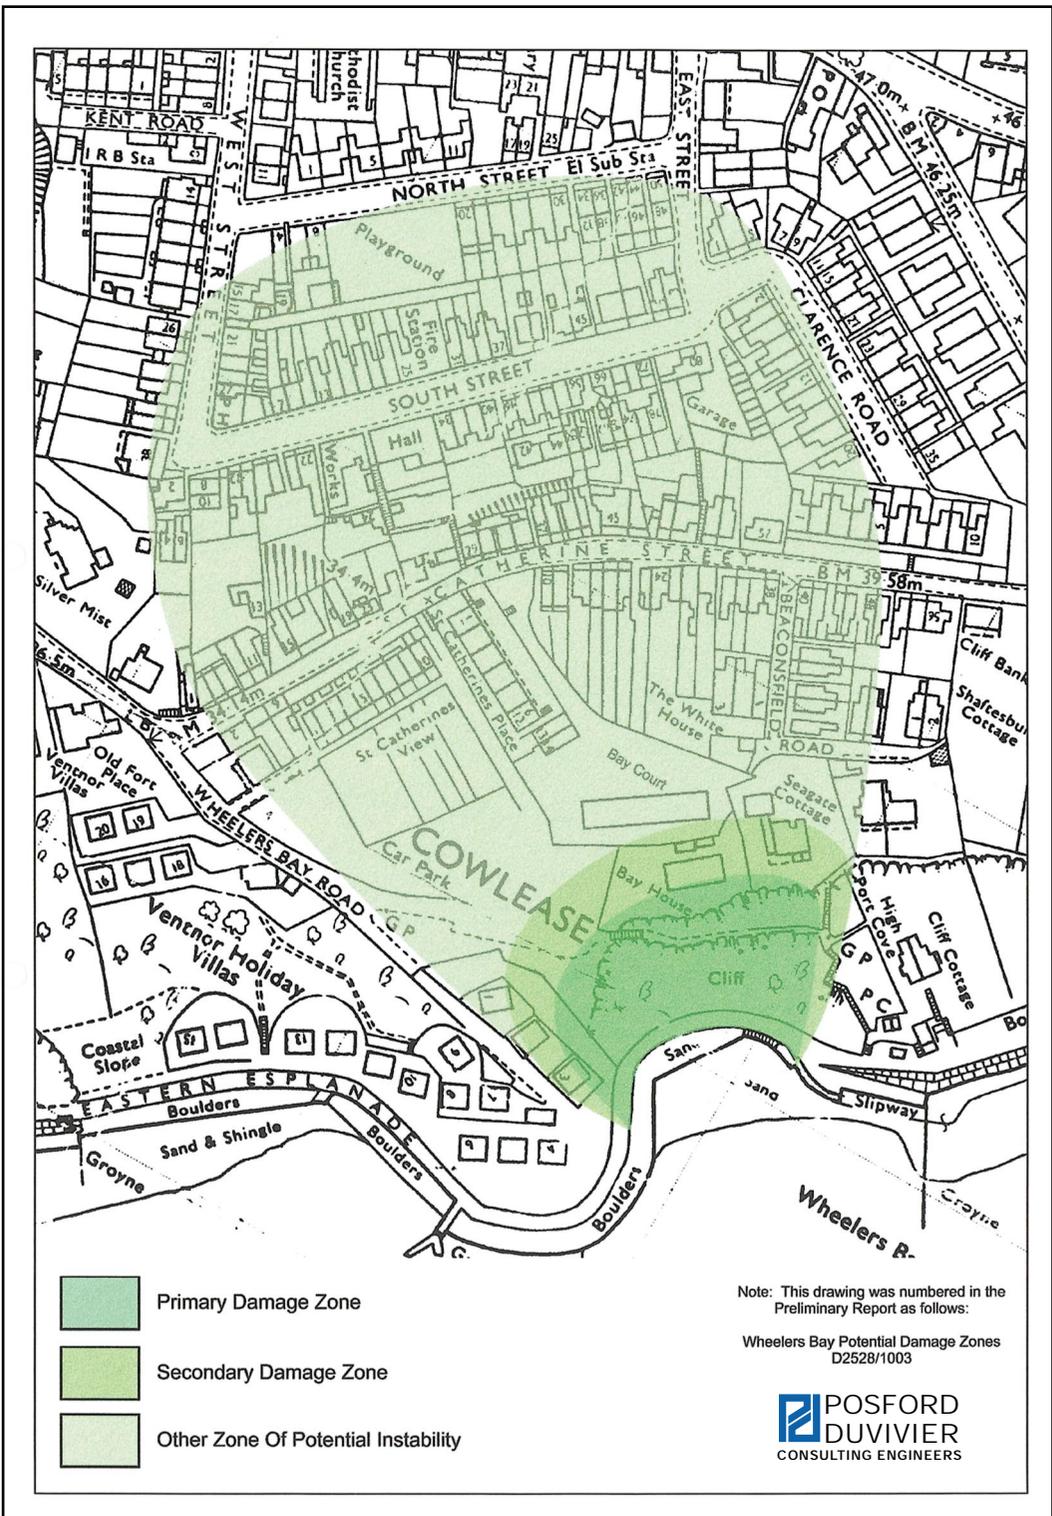
Figure G5.2 Landslide hazard map.

Wheeler's Bay (Plate G5) is located within the Ventnor Undercliff landslide complex and is situated on the eastern side of Ventnor (see Figure G5.1). A long history of ground movement and slope instability has been the subject of a number of investigations in this area but Wheeler's Bay in particular has, in recent years, become a location of serious concern, principally because ground movements threatened the integrity of assets including residential properties and coastal defences (see Figure G5.2).

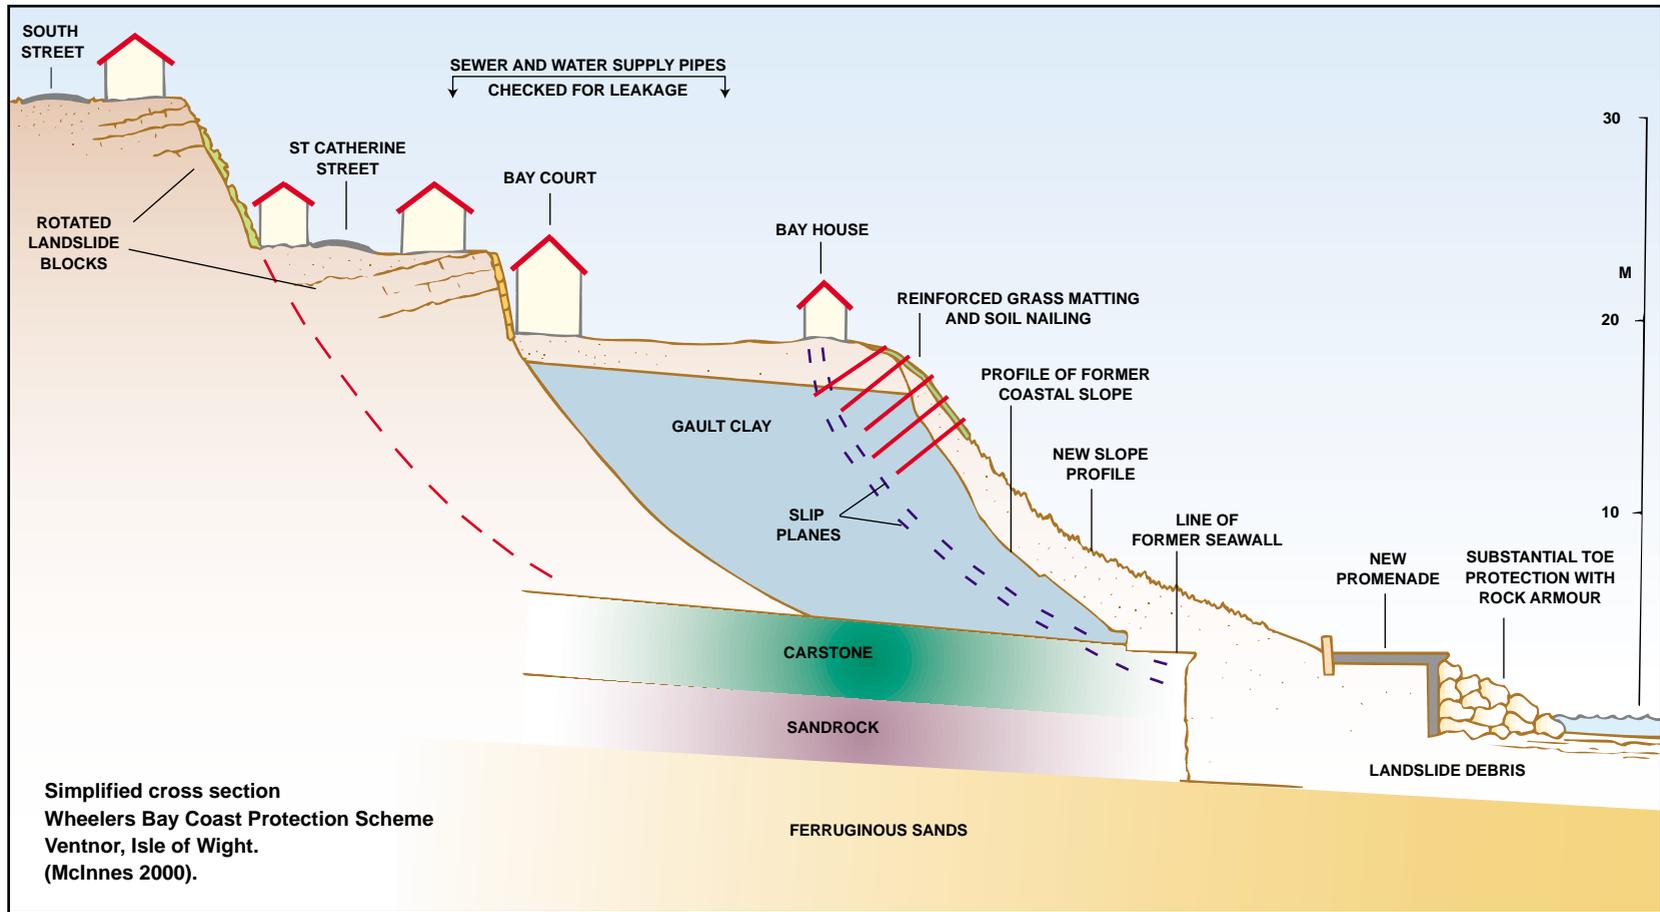
Figure G5.3 Diagrammatic cross-section through Wheeler's Bay coast protection scheme.

Historically Wheeler's Bay itself was caused by a landslip prior to 1862. Recent concerns arose in 1996 when movement was observed affecting a property at the top of the coastal slope behind the Bay. Ground investigations were subsequently carried out on the top of the cliff, on the coastal slope and on the promenade at the foot of the cliff. The results of the geotechnical investigations are illustrated in the cross-section provided (Figure G5.3) and indicate that Wheeler's Bay lies principally within the Gault Clay.

The general geological sequence at Wheeler's Bay comprised Upper Greensand, overlying Gault Clay, Carstone and Sandrock and Ferruginous Sands. Further inland, to the north of Wheeler's Bay the Greensand is overlain by Chalk. As a result of a complex sequence of landsliding, the geological sequence within the coastal slope comprises disturbed Greensand overlying Gault Clay and then undisturbed Sandrock.

light of this damaging scenario, the Council and its consultants formulated a number of potential solutions aimed at stabilising the slope at Wheeler's Bay. The preferred solution on technical, economic and environmental grounds comprised a combination of toe weighting the slope with rock armour and fill, land drainage and soil nailing. An application to the Ministry of Agriculture, Fisheries and Food for a £1.5m scheme was approved and work was completed in May 2000 (Plates G5a, G5b, G5c, G5d, G5e, G5f). The aim of stabilization of the coastal slope is to prevent further deterioration in ground stability conditions in the area and to help safeguard a large number of properties in the vicinity of Wheeler's Bay.

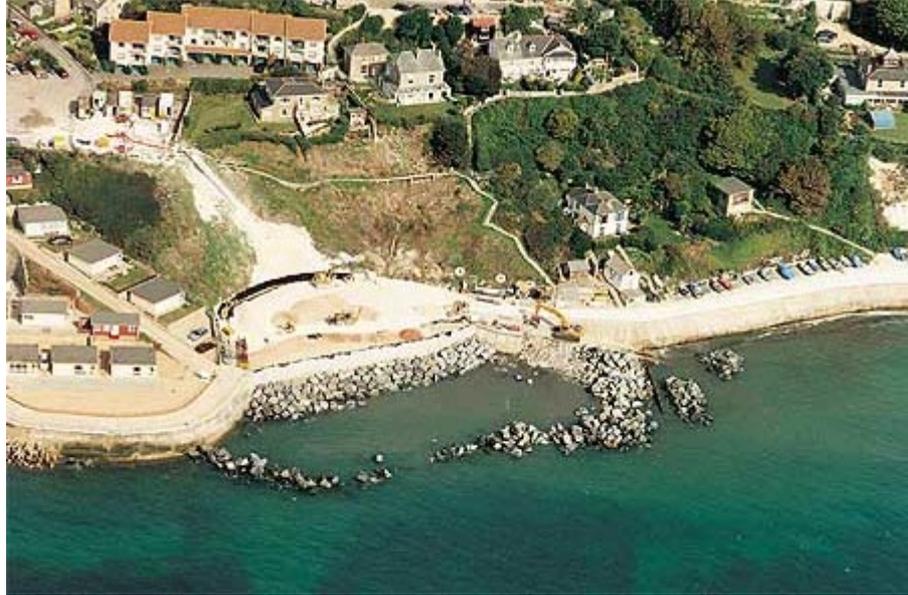
Plate 5a *Coast protection and slope stabilization works in progress, 1999
(courtesy:D.Bowie Photography)*

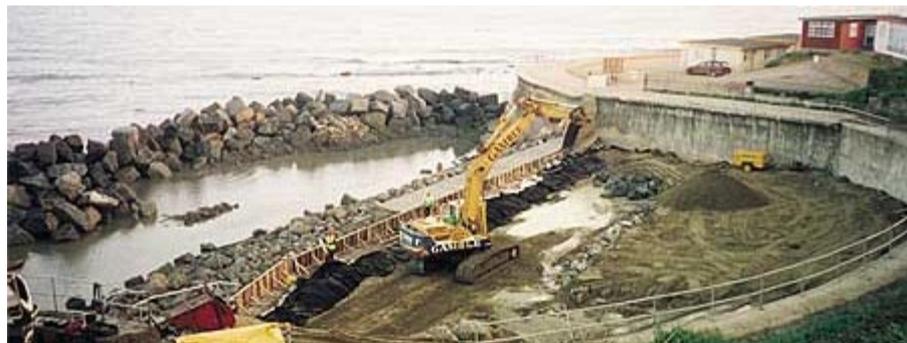
Plate 5b *Coast protection and slope stabilization works in progress, 1999
(Courtesy D.Bowie Photography)*

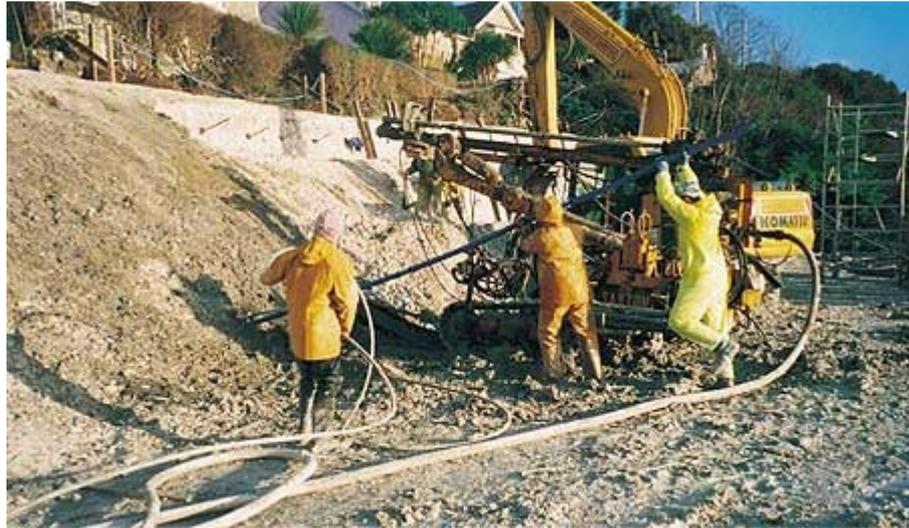
Plate G5c Soil nailing on the upper slope, 1999

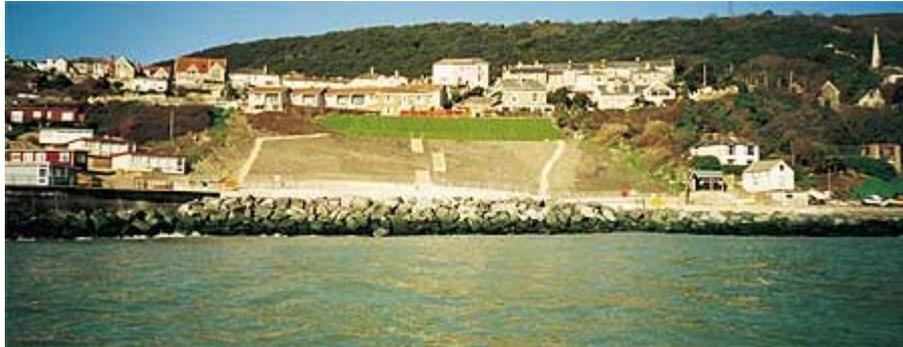
Plate G5e *The completed coast protection and slope stabilisation scheme, April 2000*

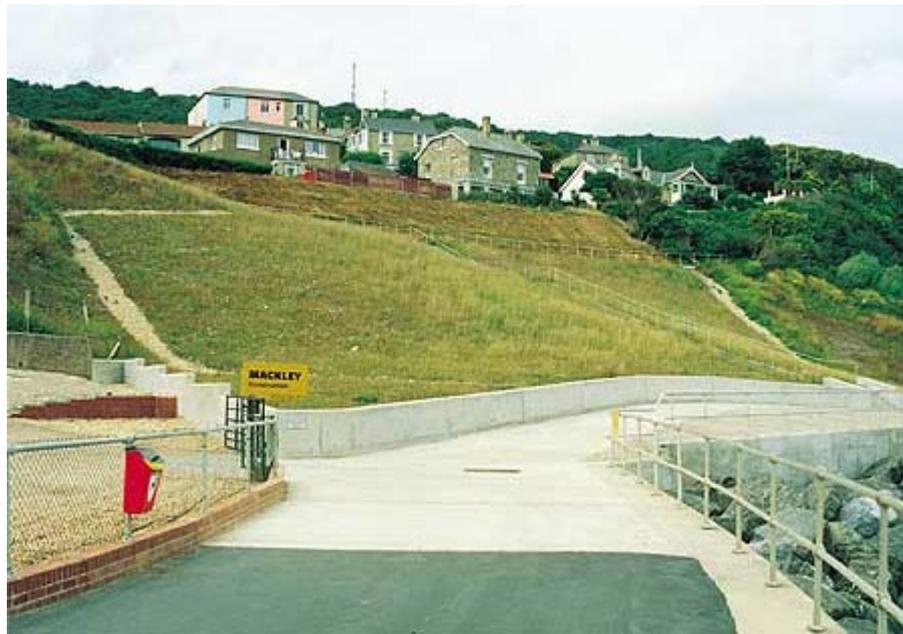
Plat G5f *The completed coast protection and slope stabilization scheme after a successful growth of grass, August 2000*
