**GEOLOGICAL  
FAILURE REPORT**  
UNDERCLIFF DRIVE: SEVEN  
SISTERS ROAD, ST  
LAWRENCE TO ST  
CATHERINE'S ROAD, NITON  
May 2014

<b>Title</b>	<b>Geological Failure Report – Seven Sisters Road, St Lawrence to St Catherine’s Road, Niton</b>		
<b>Version Number</b>	4		
<b>Document Status</b>	Final		
<b>Date of Next Review</b>	June 2014		
<b>Version</b>	<b>Report Author</b>	<b>Report Checked</b>	<b>Report Approved</b>
4

A Geological Failure has occurred at Undercliff Drive between Seven Sisters Road, St Lawrence and St Catherine's Road, Niton.

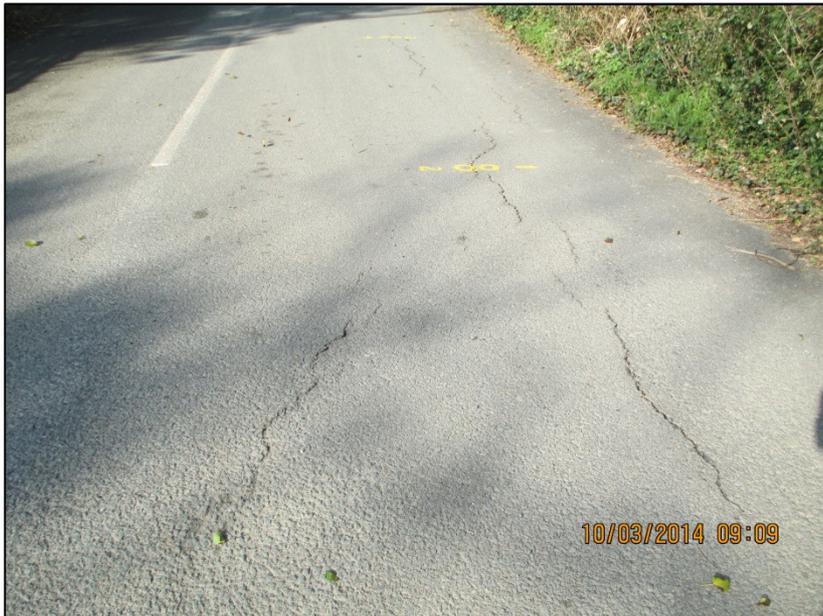
A number of tension cracks have developed at the Ventnor end of Site 8 Above Hunts Road beyond the extent of the piles that were installed during December 2013/January 2014 as part of the geotechnical works at this site (see Figs. 1a and 1b). The cracks developed over a period from early March 2010 but have now slowed and no further movement has been detected. Ground movements here can be attributed to the exceptionally high rainfall over December 2013 and January/February 2014 coupled with the intrinsic instability of the area. Groundwater levels along this stretch of the Undercliff are still well above the trigger levels for ground movement as shown in Section 2 of Appendix 1 (Woodlands Failure Report) and Appendix 2 (Caravan Park Failure Report). Ground movement appears to have slowed at the Caravan Park but is continuing in the centre of the slip at Woodlands.

**Figure 1a.**  
*Undercliff Drive  
Geological  
Failure. Tensions  
cracks  
developing at the  
Ventnor end of  
Site 8 Above  
Hunts Road.*

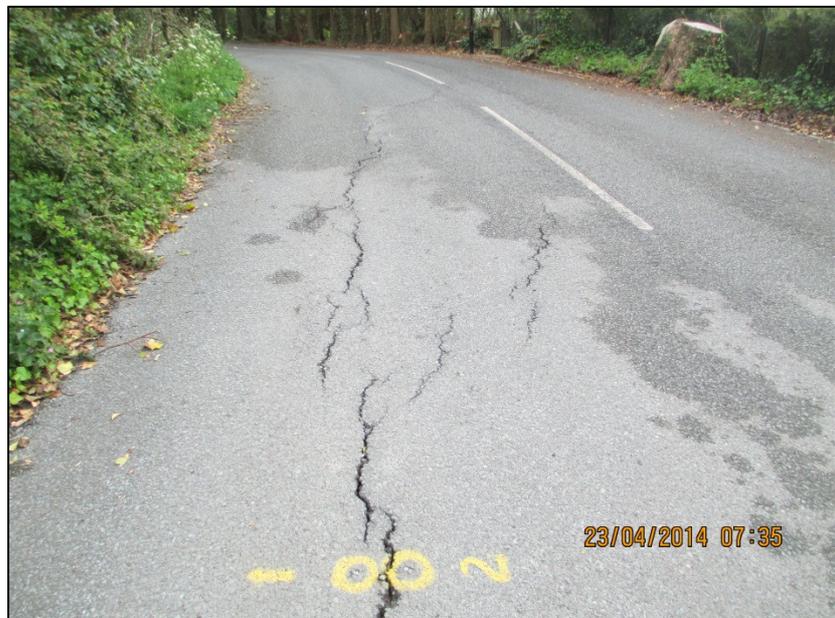
**Figure 1b.**  
*Undercliff Drive  
Geological  
Failure. Tensions  
cracks  
developing at the  
Ventnor end of  
Site 8 Above  
Hunts Road.*

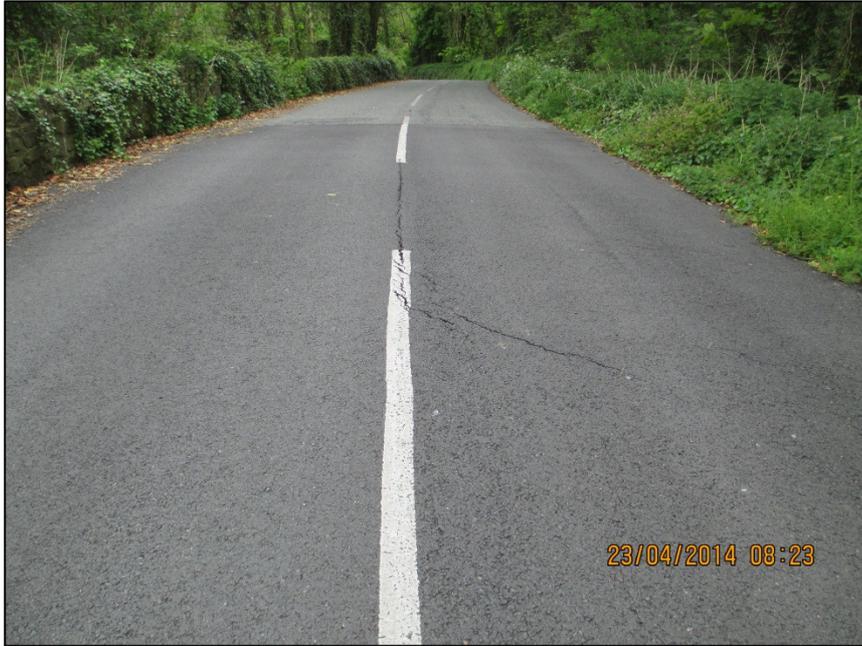
Ground movement has also occurred at Site 11 Mirables over the same time period and has been characterised by the development of hairline cracks within the carriageway. Movement has been detected by the carriageway monitoring instrument at this site and groundwater levels remain high but are now beginning to drop. One instrument located downslope of the carriageway within the landslide itself has failed due to ground movement. Photographs of the site are shown in Figs 2a, 2b and 2c. Monitoring data for the area around Site 11 Mirables are given in Fig 3a and 3b.

**Figure 2a.**  
*Undercliff Drive  
Geological  
Failure.* Tensions  
cracks  
developing in the  
carriageway at  
Site 11 Mirables.

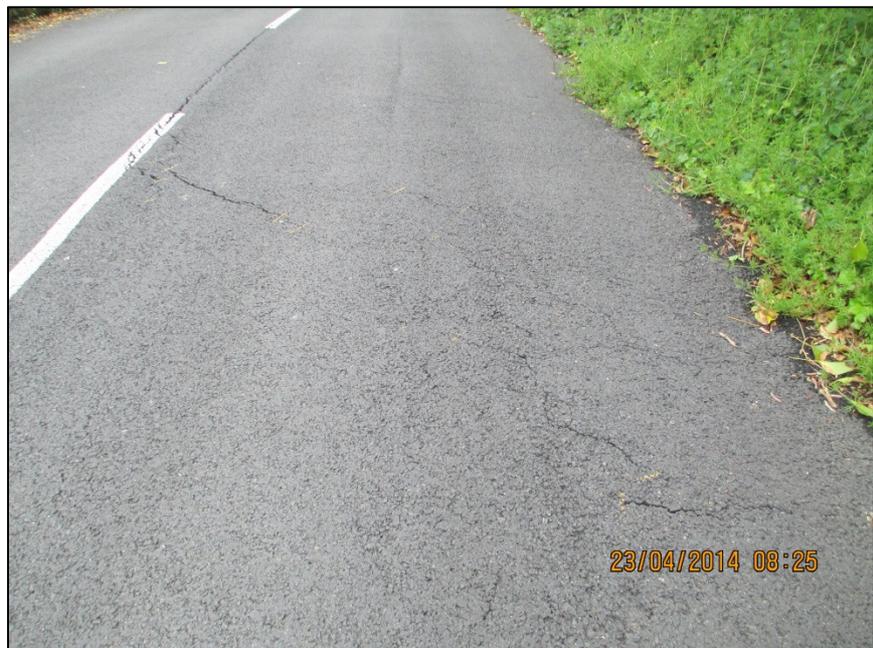
**Figure 2b.**  
*Undercliff Drive  
Geological  
Failure.* Tensions  
cracks  
developing in the  
carriageway at  
Site 11 Mirables.

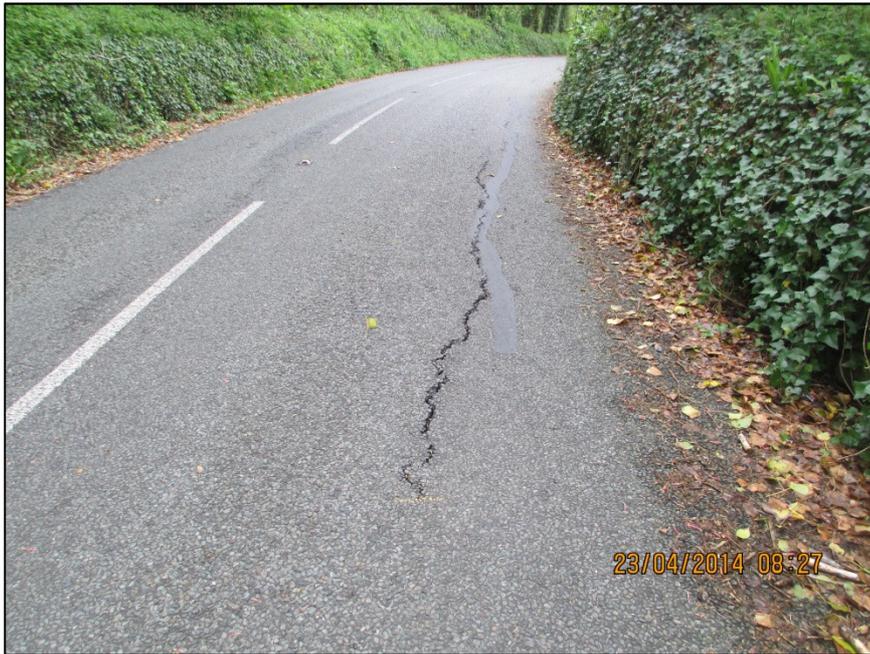
**Figure 2c.**  
*Undercliff Drive Geological Failure. Tensions cracks developing in the carriageway at Site 11 Mirables.*

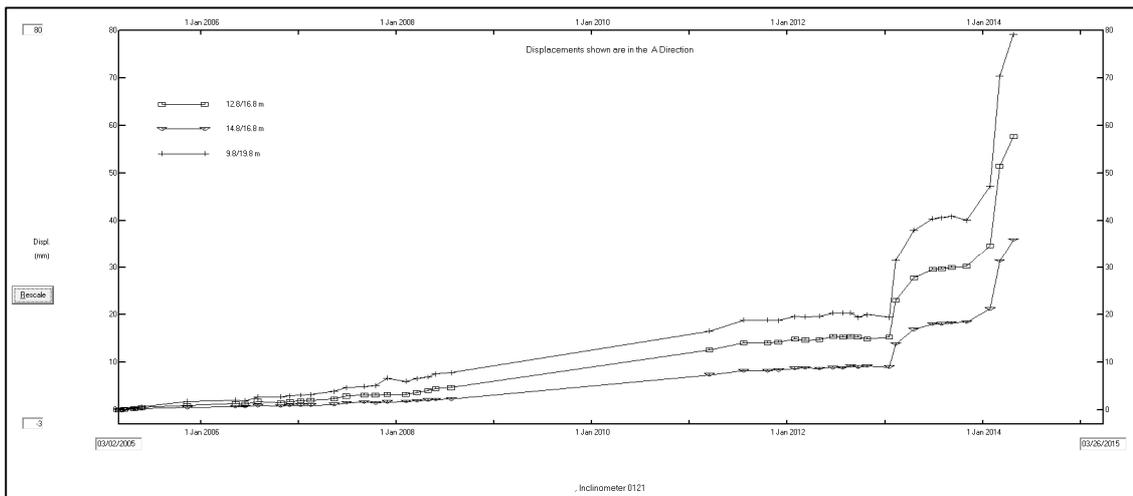
**Figure 3a.** Displacement time graph showing ground movement rates at Site 11 Mirables (instrument located within the carriageway). The A direction is downslope. The plot shows an increase in the rate of movement during January 2013 a further increase during January 2014.

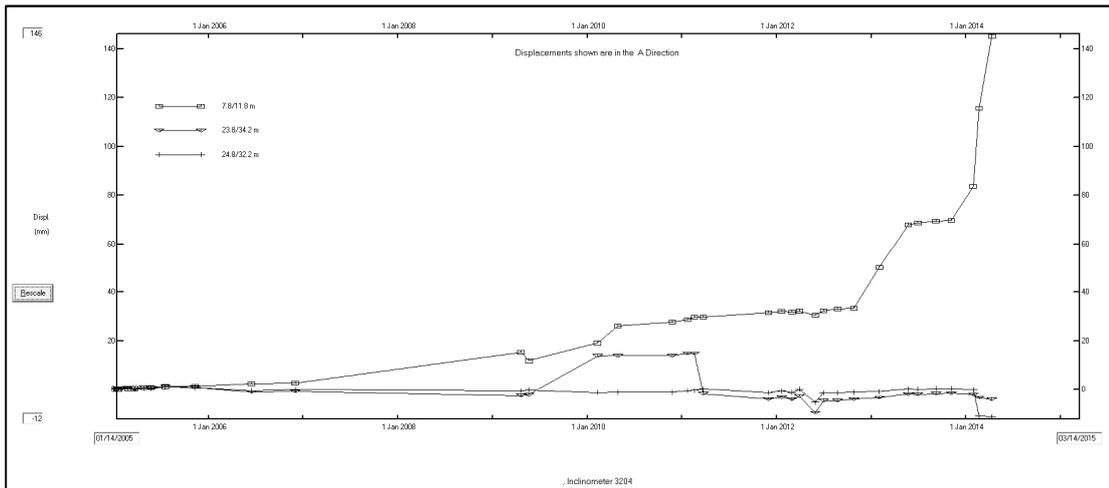
**Figure 3b.** Displacement time graph showing ground movement rates at Site 11 Mirables (instrument located within landslide). The A direction is downslope. Similarly with the plot in Figure 3a there are increases in the rates of movement in January 2013 and January 2014 to the present.

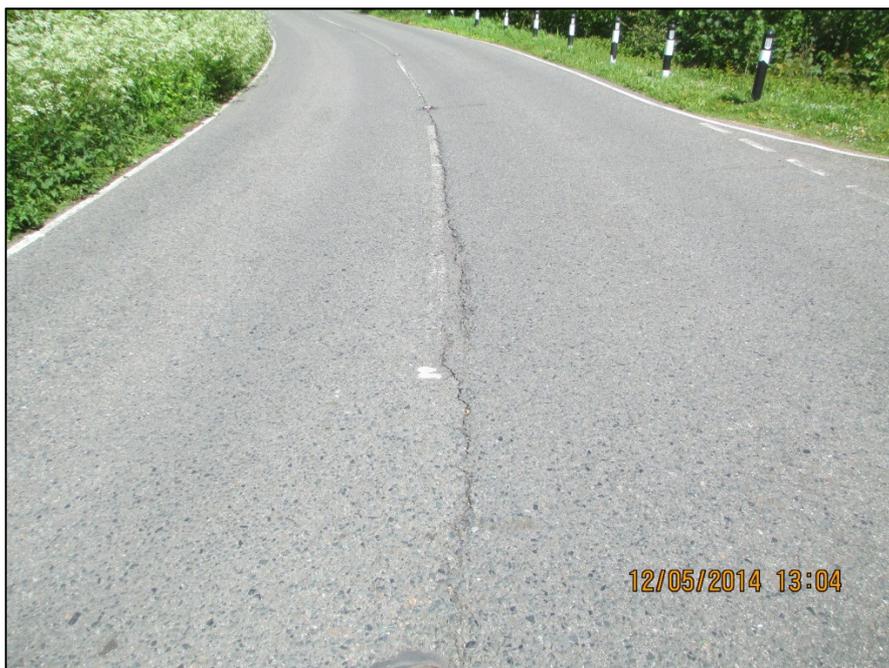
Amber Risk Zone 6 Beauchamp has also moved on a similar scale to those sites further towards Ventnor. Ground movement here has become apparent through the development of tension cracks both within the carriageway and further downslope within the landslide. Cracks have developed in residential buildings nearby, and adjacent monitoring instruments have detected movement and high groundwater water levels. Photos of the tension cracking developing at the surface are shown in Figs. 4a and 4b. Associated monitoring data is given in Figs. 5a, 5b and 5c.

**Figure 4a.**  
*Undercliff Drive  
Geological  
Failure. Tensions  
cracks  
developing in the  
carriageway at  
Amber Risk Zone  
6 Beauchamp.*

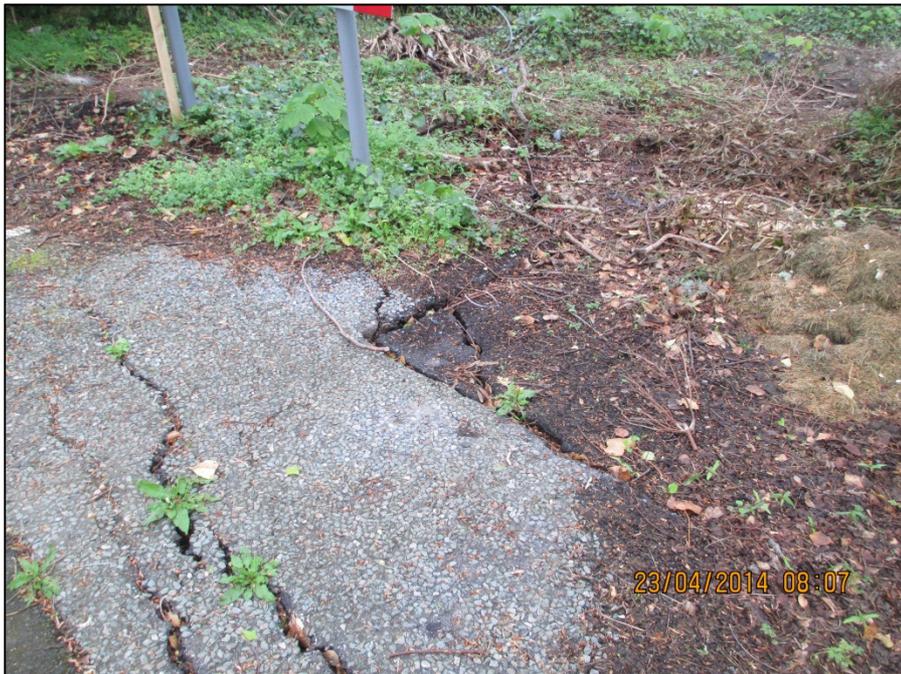
**Figure 4b.**  
*Undercliff Drive Geological Failure. Tensions cracks developing in the carriageway at Amber Risk Site 6 Beauchamp.*

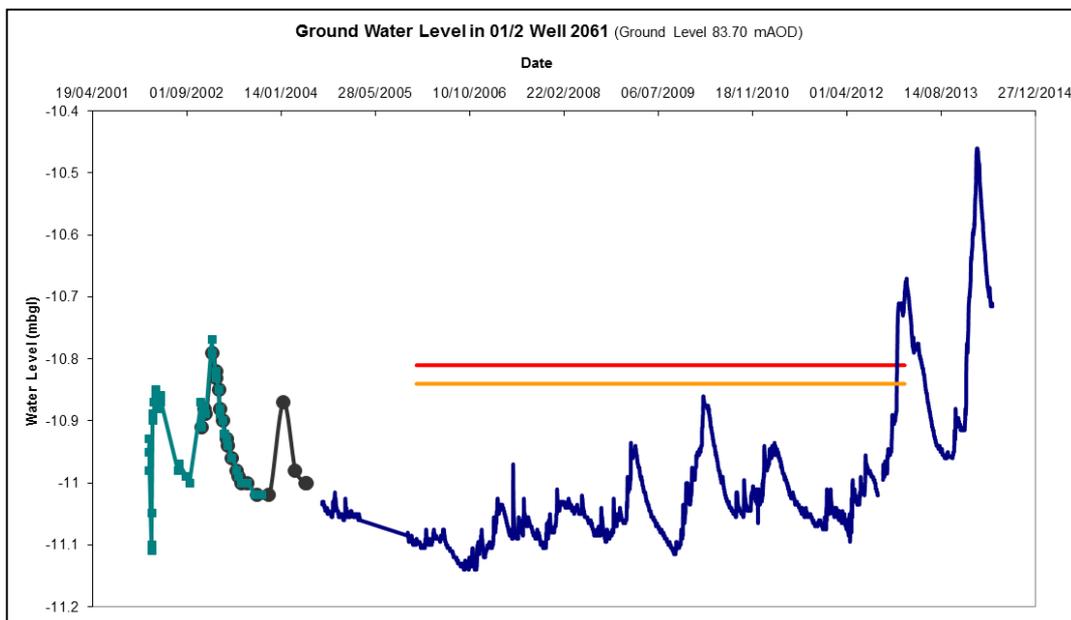
**Figure 5a.** Groundwater levels at Amber Risk Zone 6 Beauchamp. The red line denotes the trigger level for ground movement. Groundwater levels at this site have begun to drop however they remain high.

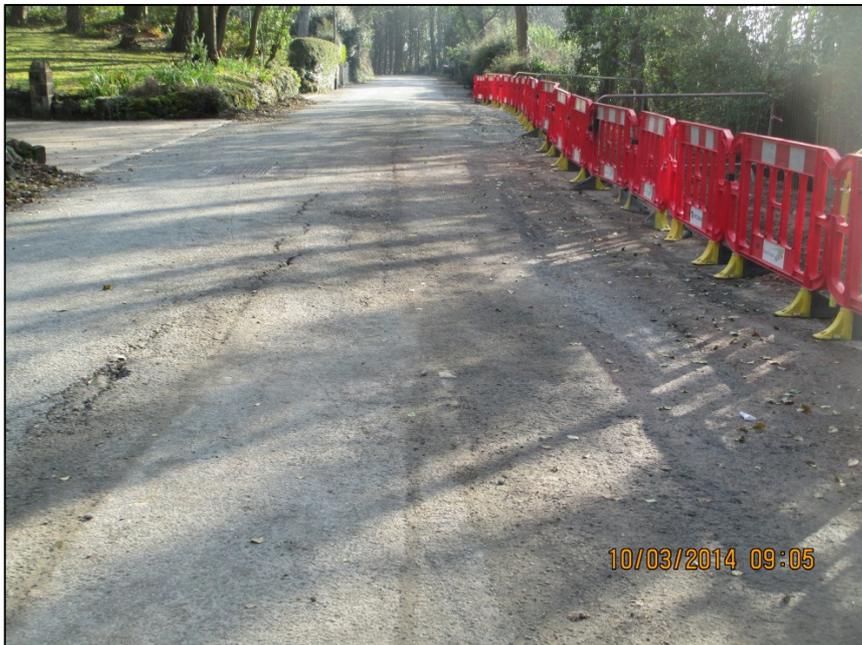
**Figure 6a.**  
*Undercliff Drive Geological Failure.*  
Measures in place at Site 8 Above Hunts Road.

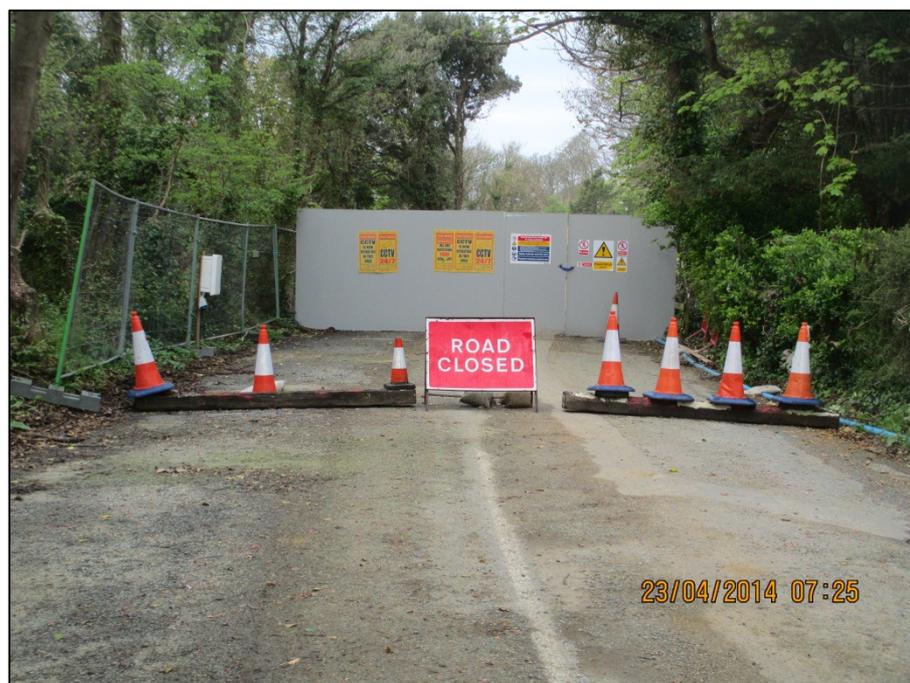
**Figure 6b.**  
*Undercliff Drive Geological Failure.*  
Measures in place at Site 9 Woodlands (eastern end).

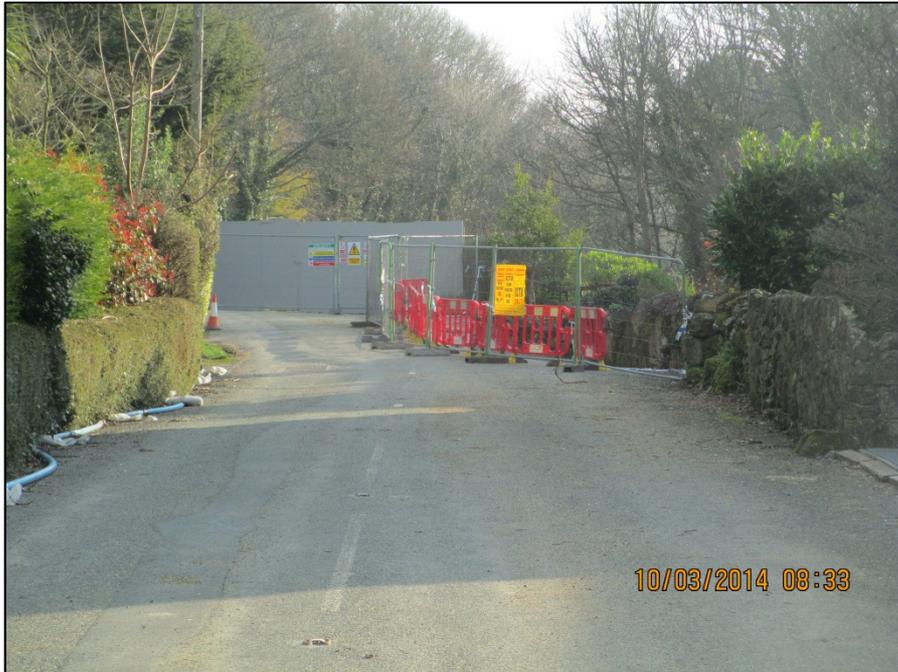
**Figure 6c.**  
*Undercliff Drive Geological Failure.*  
Measures in place at Site 9 Woodlands (western end).

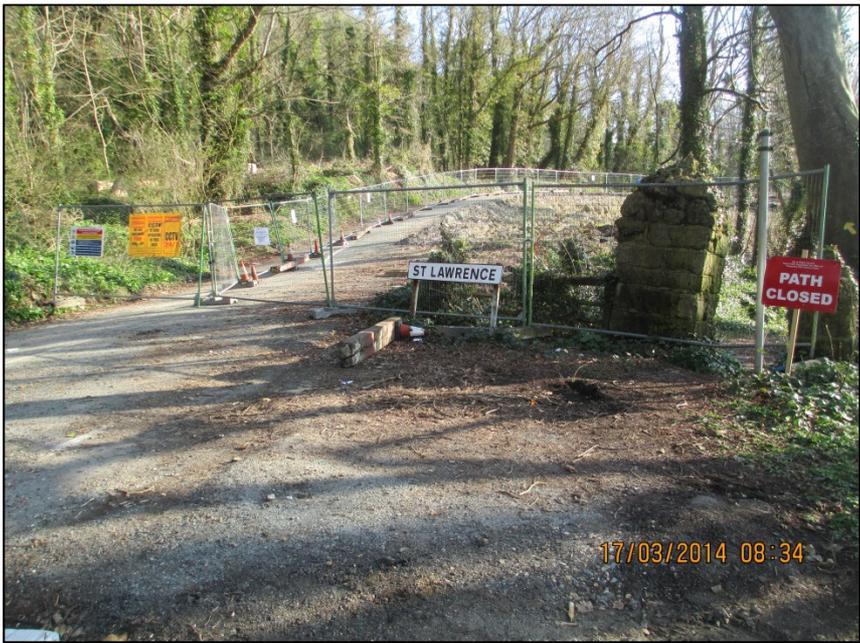
**Figure 6d.**  
*Undercliff Drive Geological Failure.*  
Measures in place at Site 10 Caravan Park (western end).

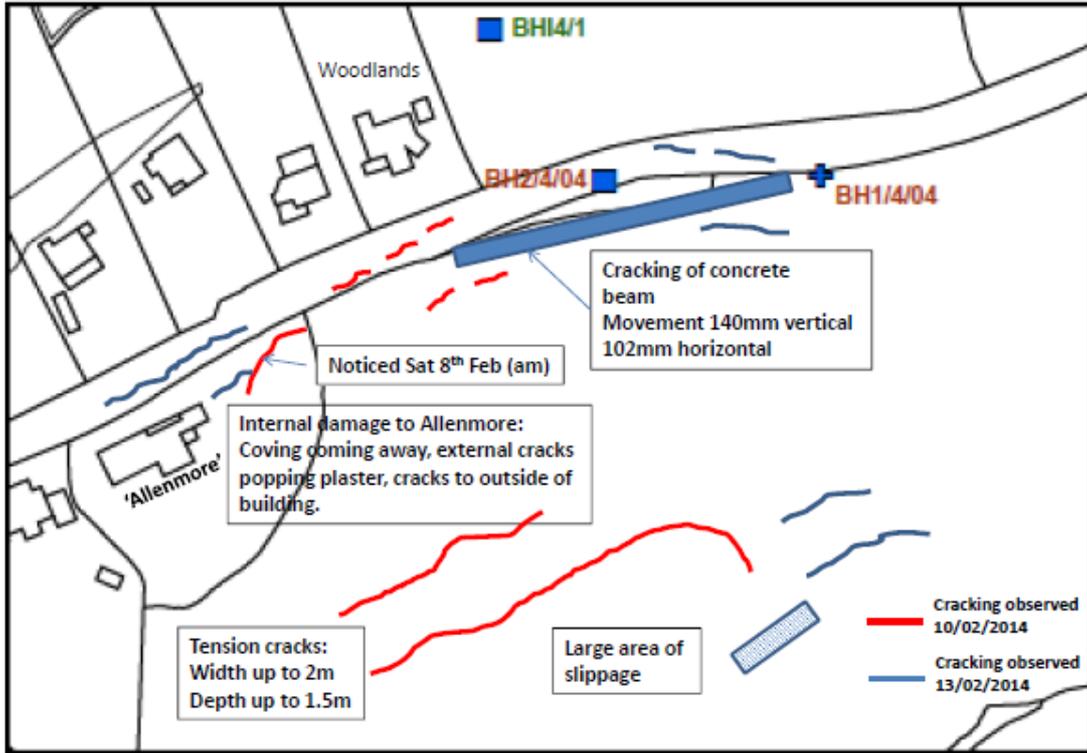
Figure 2 Summary of tension cracking observed on 10 and 13 February 2014

- Tension cracking was first reported on 8 February 2014 at "Allenmore".
- An inspection of the site was carried out on 10 February 2014. The first tension cracks were observed to extend between "Woodlands" and "Allenmore" in the road surface (shown in red) and had in three days extended both east and west.
- The tension cracks initially appeared as either re-opening of existing features or as hairline cracks.

- The westward extension of the tension cracks were aligned below and around "Allenmore". The tension crack in "Allenmore" driveway initially dropped approximately 100 mm in two days and external and internal damage was evident. Displacement then increased to 400 mm, and has since increased further. The north western corner to the foundations had moved along the dpc layer (Photo A1).

- New hairline tension cracks had developed along the Undercliff Drive to the western end of "Allenmore" (13 February 2014). These features continued to open up and displacement gradually developed from hairline to 200 mm wide on 17 February 2014.

- The tension crack opposite "Woodlands" and 30 metres east of "Woodlands" opened by 50 mm to 100 mm between 13 February and 17 February 2014 and began to show signs of downslope displacement.

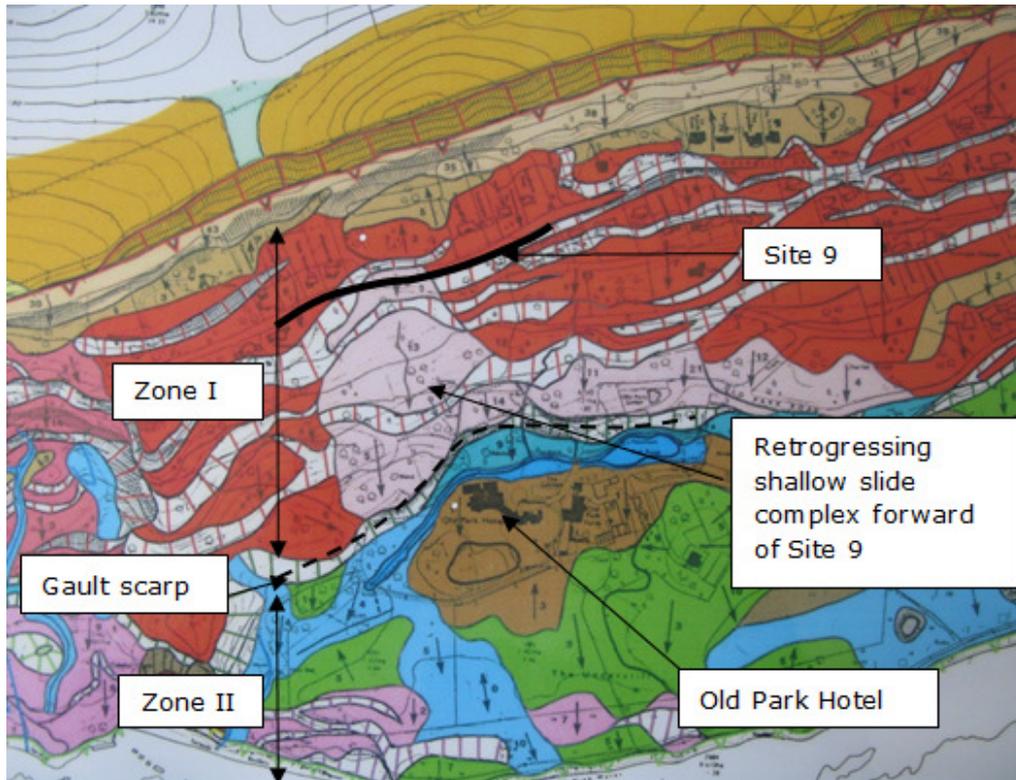
Figure 3 Extract of Geomorphology Map Site 9 and Site 10

be located in the head scarp position of an area of multiple rotational block failures that lies immediately above a retrogressing mudslide complex. The retrogressing slide complex extends approximately 160 metres downslopes of Site 9. This is in contrast to Site 10 where the mudslide complex extends to the shoreline. A zone of rotational blocks forms a feature separating the landslide complexes downslope of each site.

The site observations suggest that shallow movement within the retrogressing mudslide complex has occurred, and this is likely to have removed support to the landward rotational blocks. A rotational block appears to have reactivated in the zone separating Site 9 and Site 10, and a new feature (or old dormant feature) developed 150 metres westwards, south of the red sites, to and beneath the Caravan Park.

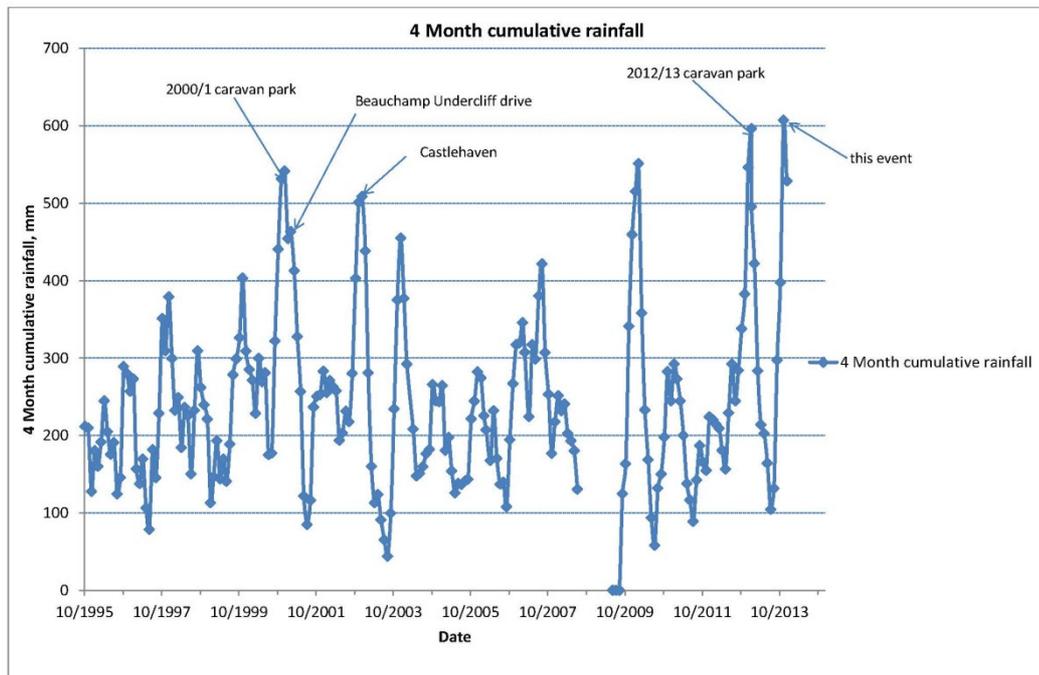
**Figure 4 Four Month Moving Average Rainfall and Landslide Events**

Subsequent to previous large scale ground movements along the Undercliff, a landslide forecast model was developed for the Undercliff by High-Point Rendel in 1996 based on the work by Lee *et al* (1991). In order to try and predict the likelihood of future movements along the Undercliff, data was collected concerning the occurrence and location of previous landslides and the volume of rainfall preceding them. The model gave a threshold value of effective rainfall (the percentage of total rainfall that enters the ground) over a preceding 4 month period which would be likely to cause instability or increased ground movement rates within the Undercliff landslide complex. When comparing the occurrence of previous landslide events with the corresponding 4 month antecedent effective rainfall (4AER) value it appears to correlate with ground movement events with a good degree of accuracy (Figure 4). Once the 4AER value drops back to below the threshold value the likelihood of further movements at that point in time is reduced. The Isle of Wight Council has employed this model in order to aid assessment of the likelihood of ground movements in areas throughout the Undercliff. Table 2 summarises the trigger threshold values. This placed the rainfall during February and March 2014 as Class 3, and at risk of major instability.

Minor events at Woodlands typically occur in Class 2 events when the 4 month AER value is between 410 mm and 540 mm.

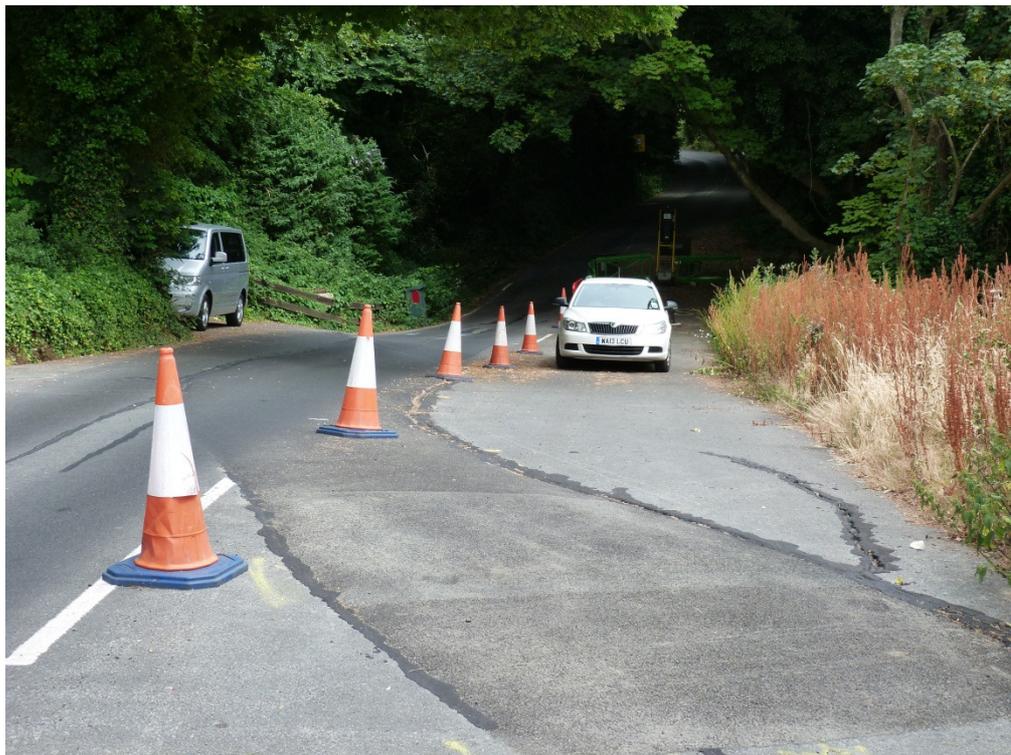
**Figure 6 View of Site 9 taken on 24 July 2013 showing resurfacing carried out prior to contract award**

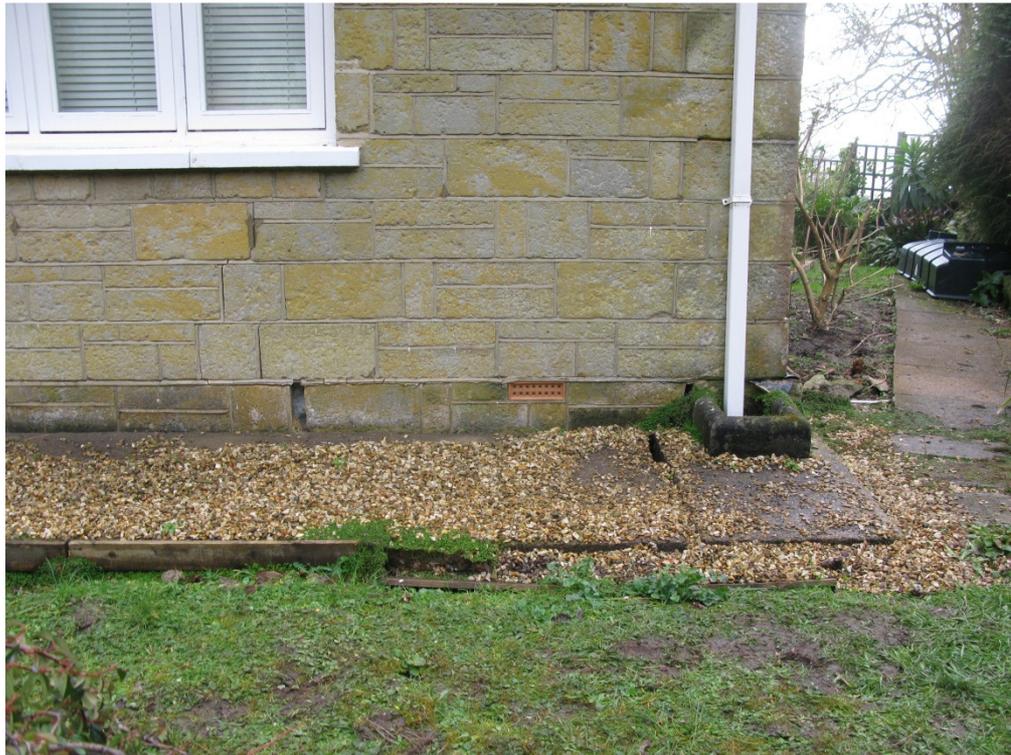
**A 1 1 Photo of north west corner of Allenmore showing foundation displacement**

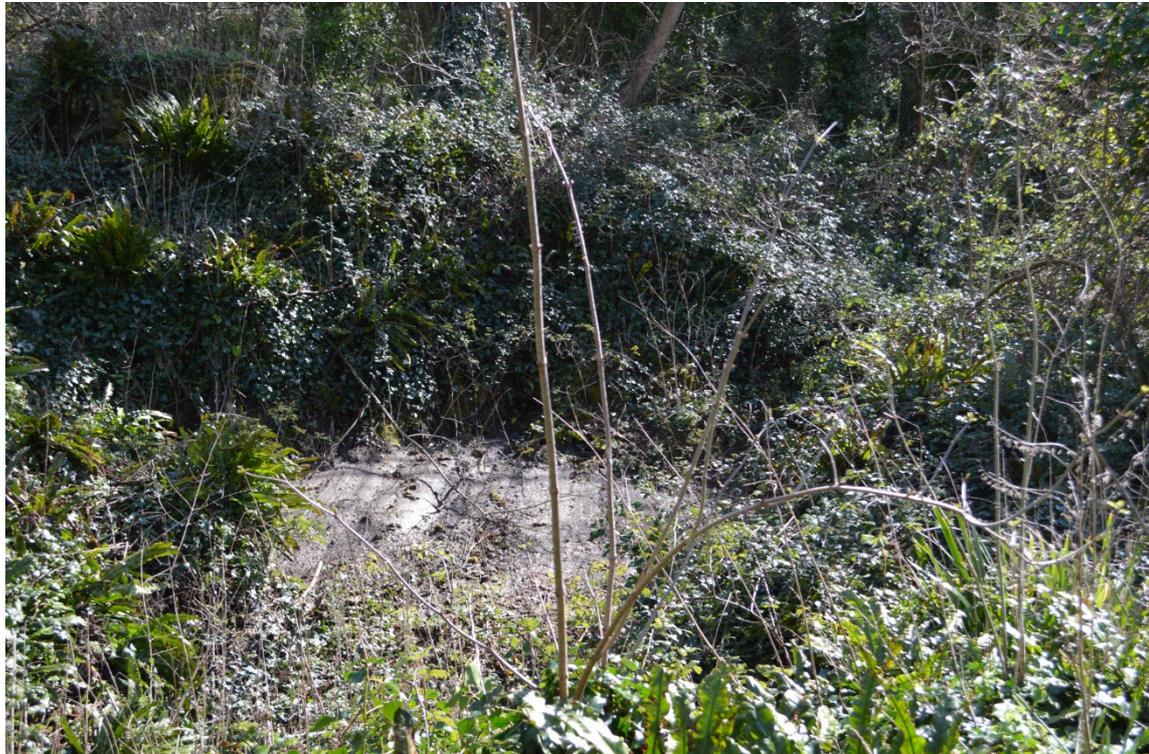
**A 1 2 Shallow sliding Downslope of the Site**

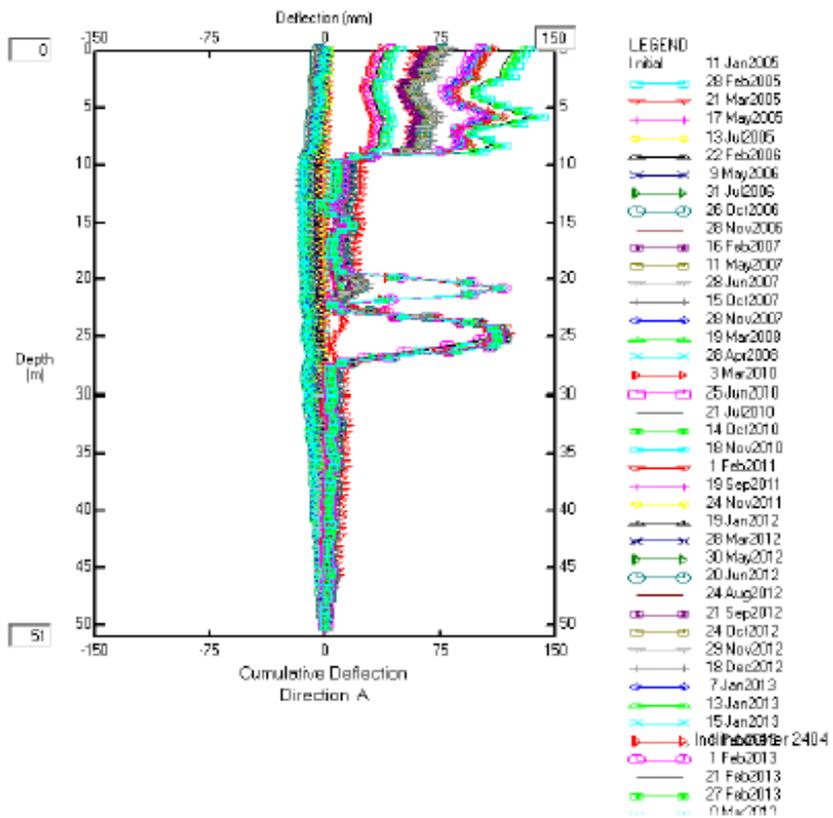
**Appendix B- 10 Inclinometer 2404 Incremental Plot. This instrument was severed due to ground movement during January/February 2013.**

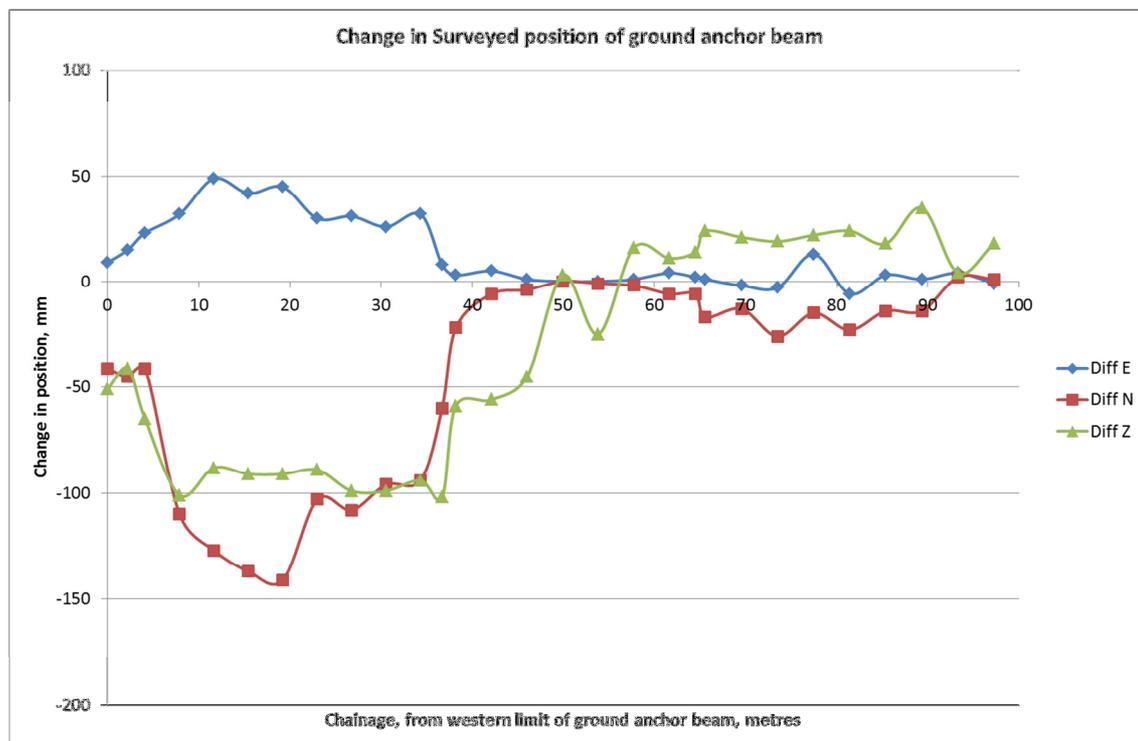
- The ground anchor beam had multiple hairline cracks at its mid-point (13 February 2014). The beam was subsequently mechanically cut before the larger scale movement began, to save as much of the beam as possible.

**Appendix B- 12 Change in Ground Anchor Beam Level from construction to 14th February 2014 (Movement direction: Diff E: Easting, Diff N: Northing, Diff Z: Level).**

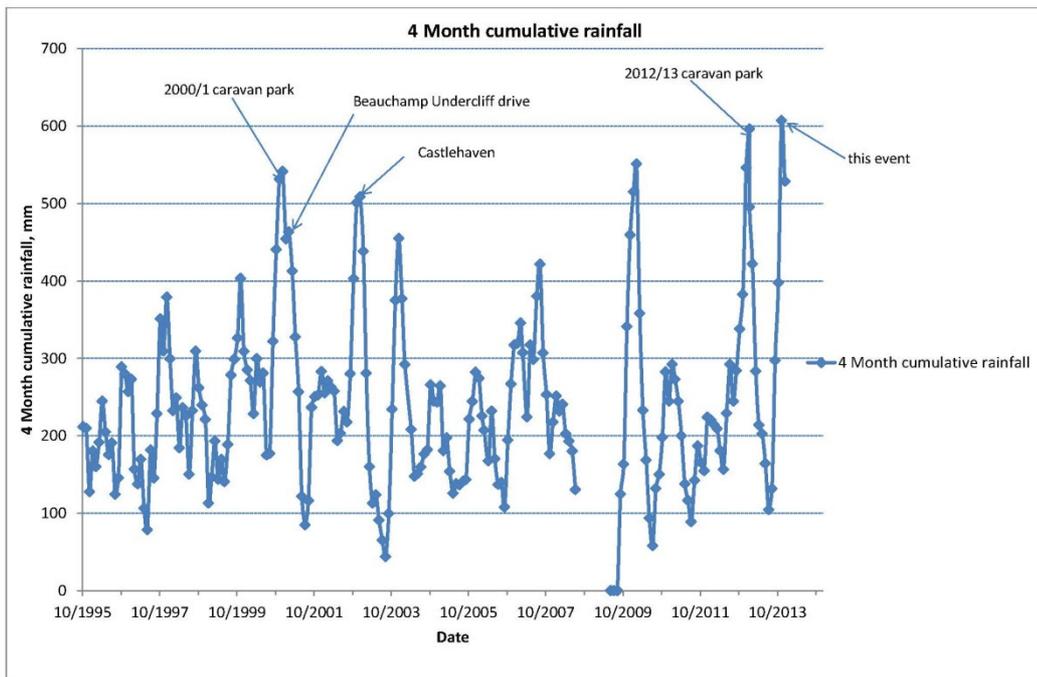
Figure 2 Four Month Moving Average Rainfall and Landslide Events

In December 2012 another period of heavy rainfall caused new cracks to develop in the open east bound carriageway and extension of those already present on the west bound side. During similar heavy rainfall in December 2013/January 2014 significant ground movements occurred throughout the area of the 2001 landslide characterised by the opening of large tension cracks across the adjacent footpath, very slow moving clay flows (within the landslide and down to the beach at Binnel Bay) and a number of fallen trees. Movement was also evident on the carriageway with the extension and propagation of the tension cracks in the west bound carriageway.
