Ryde Flood Investigation – Incident Response Phase 1 Review

Final Report

Prepared for:
Environment Agency

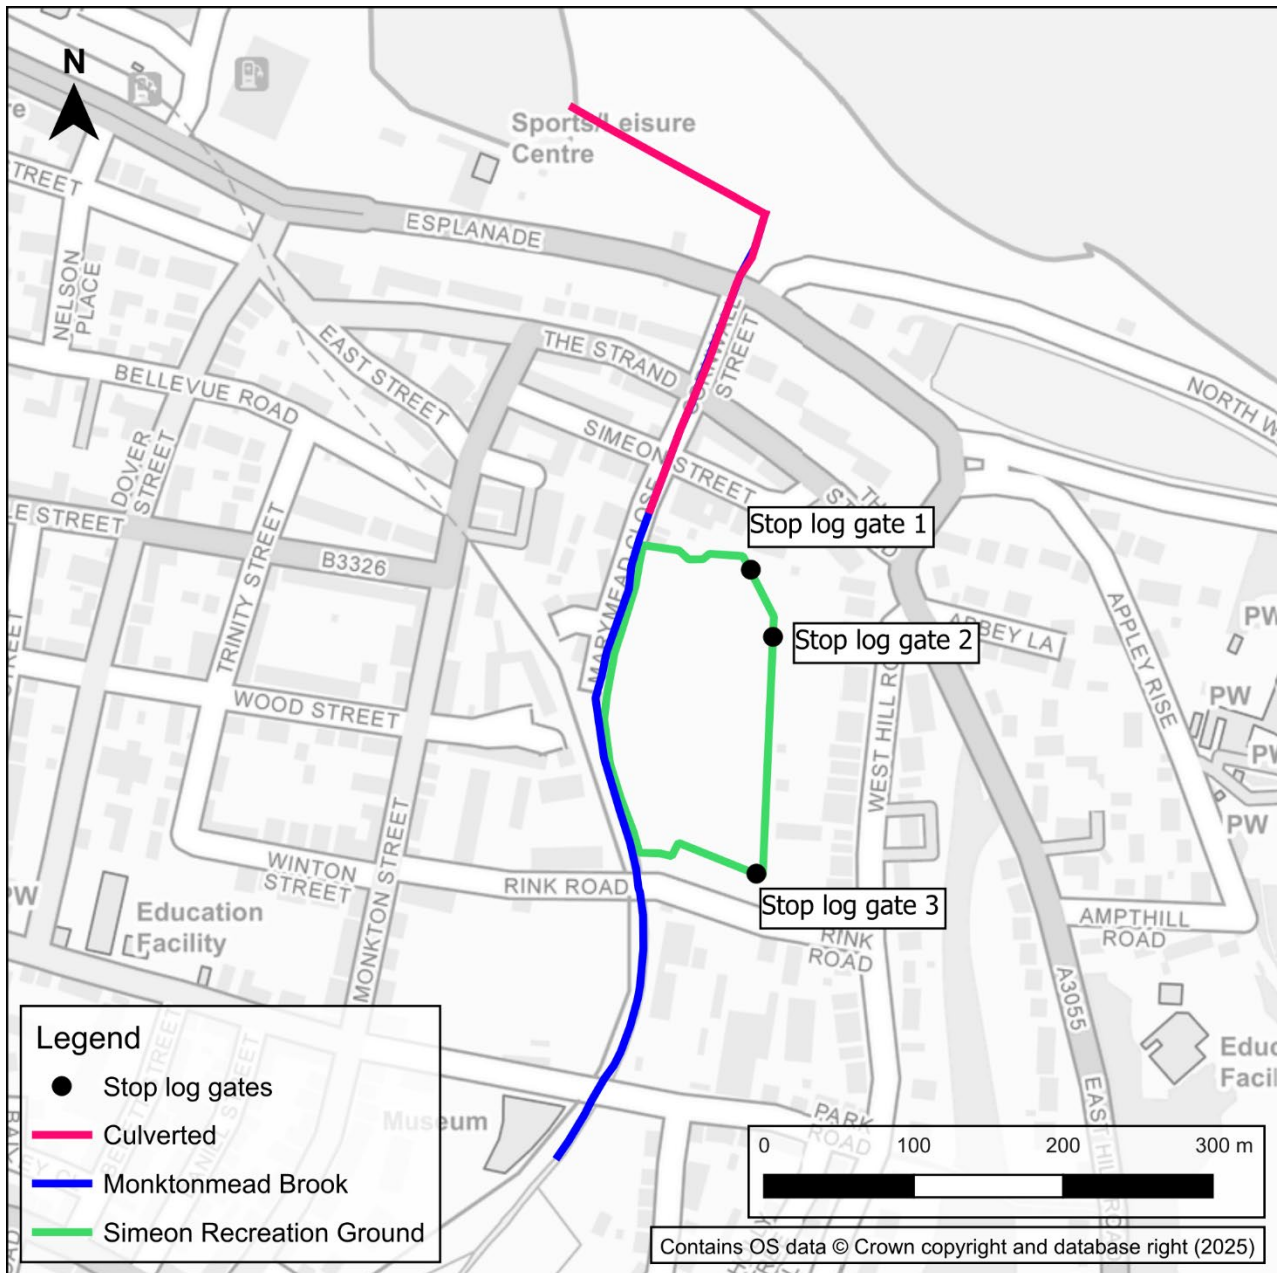
Figure 1-1: MFAS at Simeon Street Recreation Ground

In 2019, the EA upgraded the existing Monktonmead Flood Alleviation Scheme (MFAS), this included constructing a floodwall around the Simeon Street Recreation Ground. The recreation ground is a designated flood storage area surrounded by an approximately 1.3m high floodwall with three access points (stop log gates) that can be blocked off with a maximum of five/ six stop logs each approximately 0.2m in height. The scheme was designed to protect properties against flooding from a 1% AEP (1 in 100 year) fluvial event.

On 25th October 2023 a decision was made to initially install two of the stop logs at each access point at Simeon Street Recreation Ground rather than installing all five (or six) stop logs.

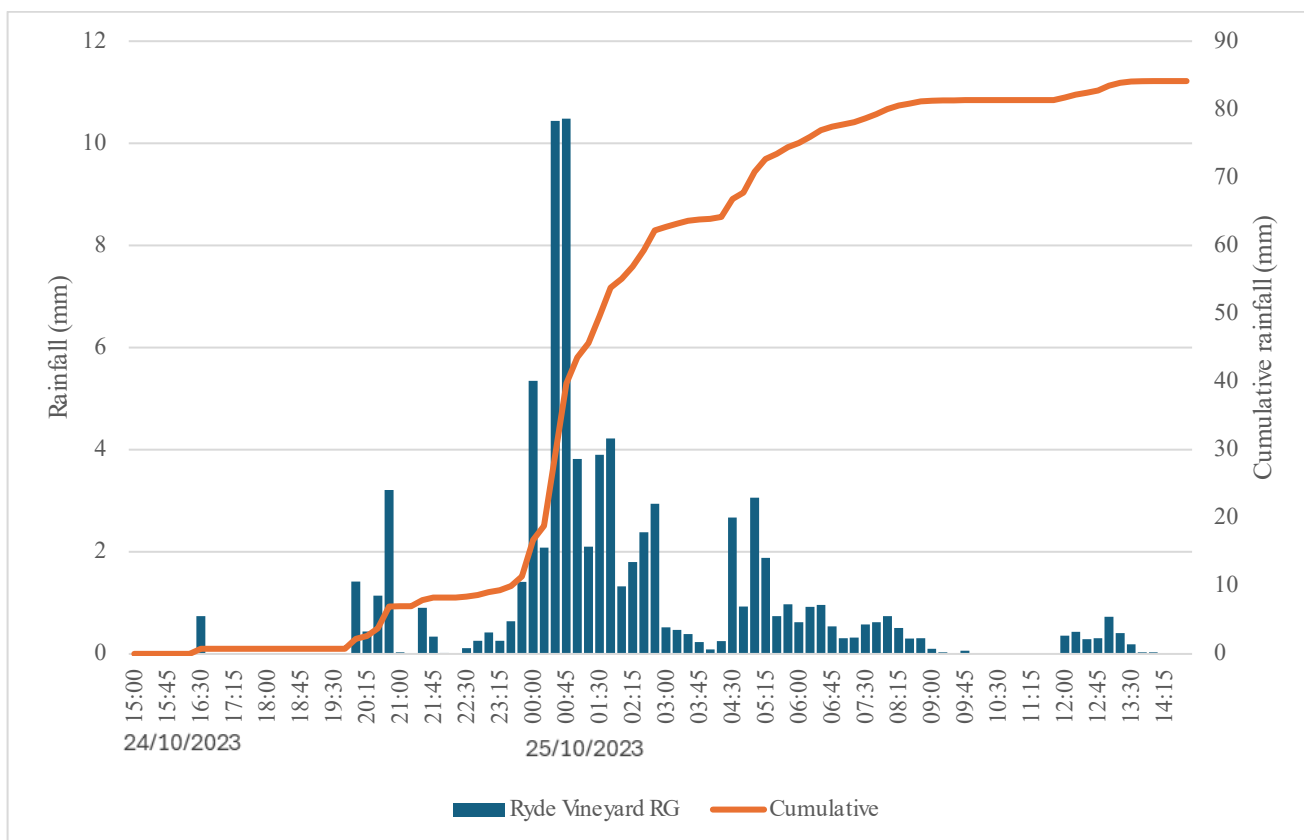
Figure 2-1 Recorded rainfall at Ryde rain gauge during flood event.

The rainfall profile measured at Ryde Vineyard TBR for 24th and 25th October 2023 is presented in Figure 2-1. A rainfall record was also provided alongside the duty officer logs. The record provided shows that 7.9mm was recorded as of midnight on the 24th October 2023, with the record commencing presumably earlier that day. This is roughly in line with the widespread totals that were forecast for this period.

It is understood that the EA based its incident response on the reasonable worst case as detailed at paragraph 2.1.1 above. It should be noted that average monthly rainfall for Ryde in October 2023 was the highest ever recorded on the gauge's 74-year history. This unprecedented and unexpectedly high level of rainfall, contrary to what was forecast may have impacted incident response during the event.

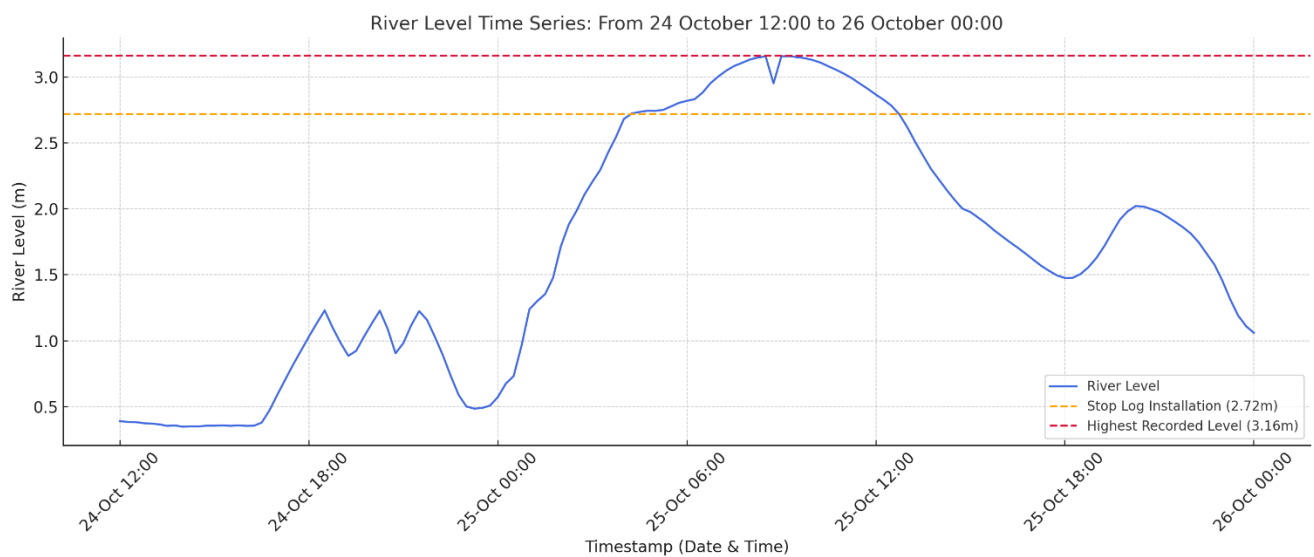
Figure 2-2 river level recorded at Monktonmead gauging station between 23/10/23 and 27/10/24.

- River levels at Monktonmead gauging station started to rise at 23:30.
- The Monktonmead Brook reaches 2.30mAOD at 03:15 and reaches 2.72m at 04:15.
- The Monktonmead Brook peaks at 09:15 when the gauge records a river level of 3.16m (Figure 2-2).

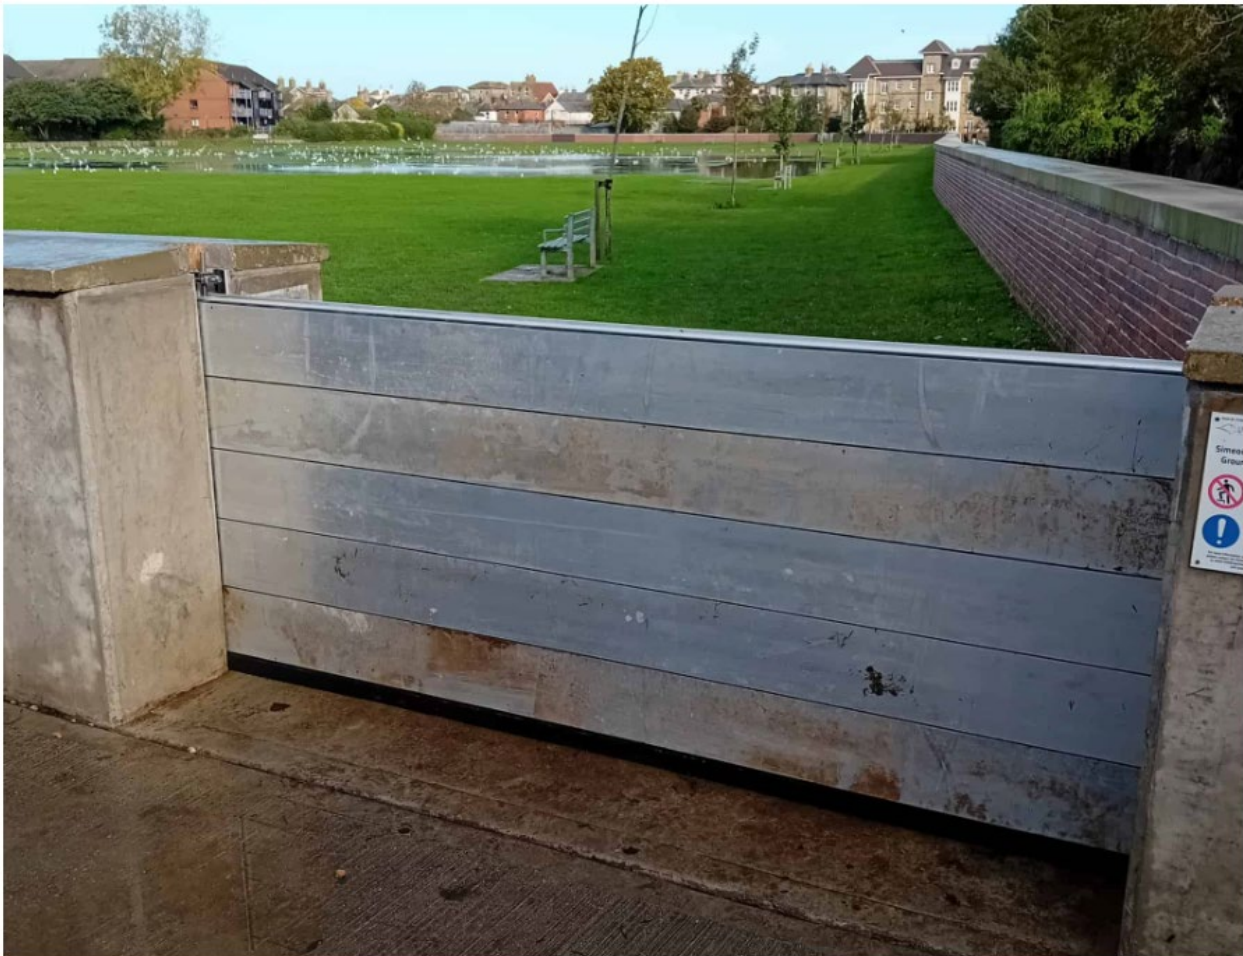
The TDDP allows for a partial deployment of the stop logs in the southern stop log gate in the interests of managing surface water. The FIDO/ FWODO logs also acknowledge the need to wait until water levels exceed bank levels before installing the stop logs at the south of Simeon Street Recreation Ground as this can otherwise prevent surface water entering the recreation ground, backing up and causing flooding.

The decision to install only two stop logs at the other gates is unlikely to have materially affected the scheme’s performance. Even with full deployment at those two gates, the system would not have operated as designed while the southern gate only had two stop logs deployed. It was not possible for the incident response contractor to complete the installation as they were unable to return to the site due to flooding. It should be noted that the installation of two stop logs in all of the gates, as occurred would have provided some flood storage and therefore some mitigation in flood risk terms.

Flood gates at Simeon Rec on Thursday morning © Michael Lilley

Figure 3-1 Reference photograph of Simeon Street Recreation Ground Flood Wall and installed stop logs. Image taken from <https://onthewight.com/could-additional-flood-boards-at-simeon-rec-have-prevented-flooding-environment-agency-to-investigate/>. Date accessed 3rd January 2025.
