Isle of Wight Shoreline Management Plan 2

Appendix D Natural and Built Environment Baseline (Thematic Review)

December 2010

Coastal Management; Directorate of Economy & Environment, Isle of Wight Council

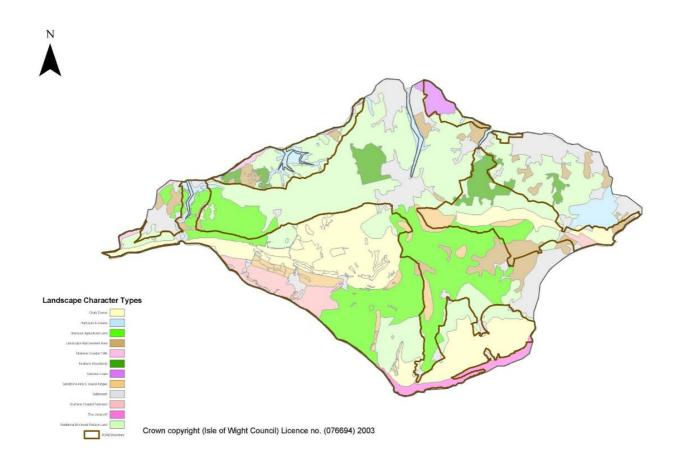
Figure D.3.2 A map of the Island showing the distribution of various landscape character types.

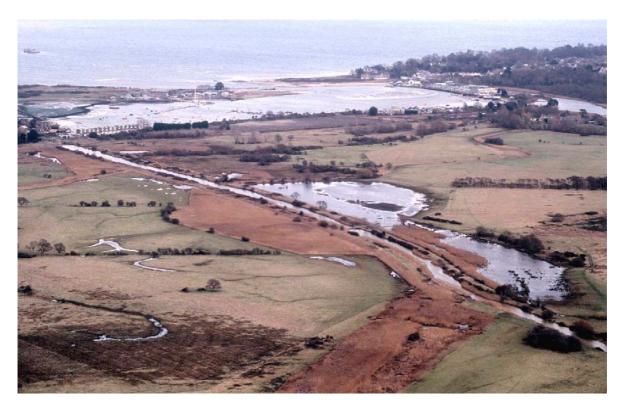
Figure D.6.IW15.1 Bembridge Harbour and the Eastern Yar river, reclaimed in the 1880s,

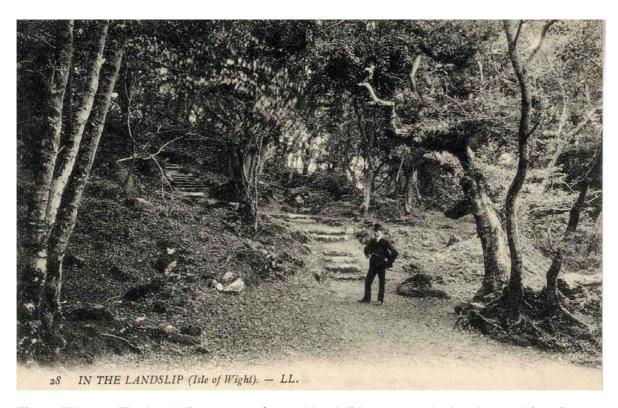
Figure IW29.3.1 The Landslip c. 1900. Coastal landslide topography has been a historic feature of the natural environment of the area and a local attraction
