**GEOLOGICAL  
FAILURE REPORT**  
UNDERCLIFF DRIVE: SEVEN  
SISTERS ROAD, ST  
LAWRENCE TO ST  
CATHERINE'S ROAD, NITON  
May 2014

<b>Title</b>	<b>Geological Failure Report – Seven Sisters Road, St Lawrence to St Catherine’s Road, Niton</b>		
<b>Version Number</b>	4		
<b>Document Status</b>	Final		
<b>Date of Next Review</b>	June 2014		
<b>Version</b>	<b>Report Author</b>	<b>Report Checked</b>	<b>Report Approved</b>
4

A Geological Failure has occurred at Undercliff Drive between Seven Sisters Road, St Lawrence and St Catherine's Road, Niton.

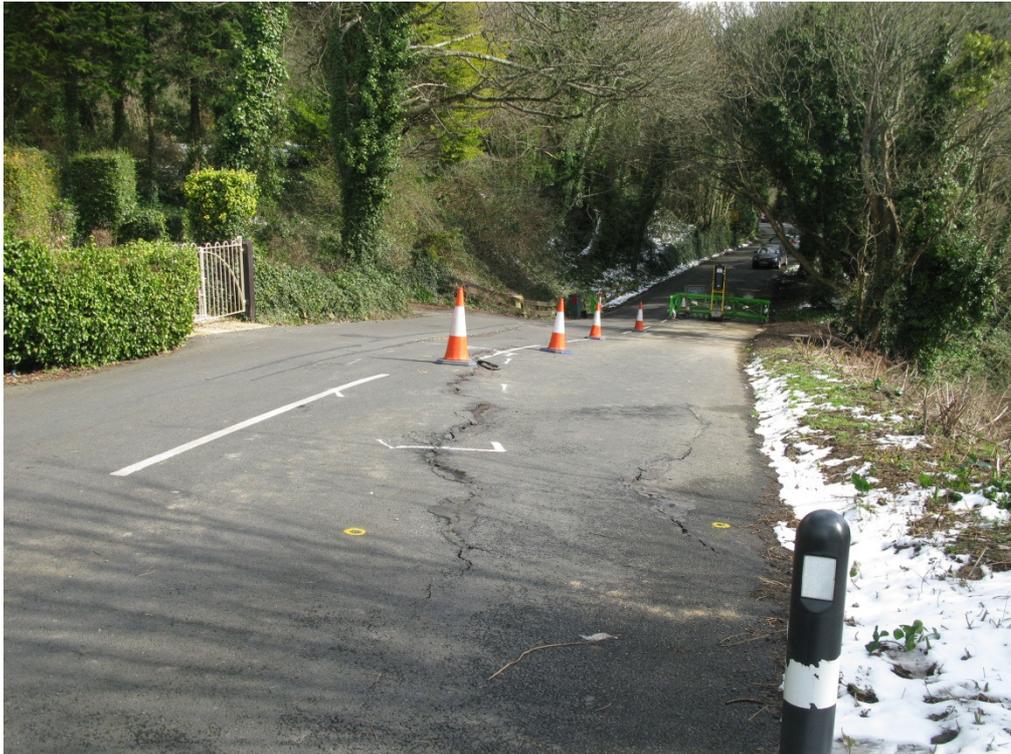
An image of the site taken on 12 March 2013 is shown in Figure 5. Localised resurfacing was carried out prior to Contract award. A site inspection was carried out on 24 July 2013 during the detailed design phase. An image taken of the site at that time is shown in Figure 6.

**Figure 5 View of Site 9 taken on 12 March 2013**

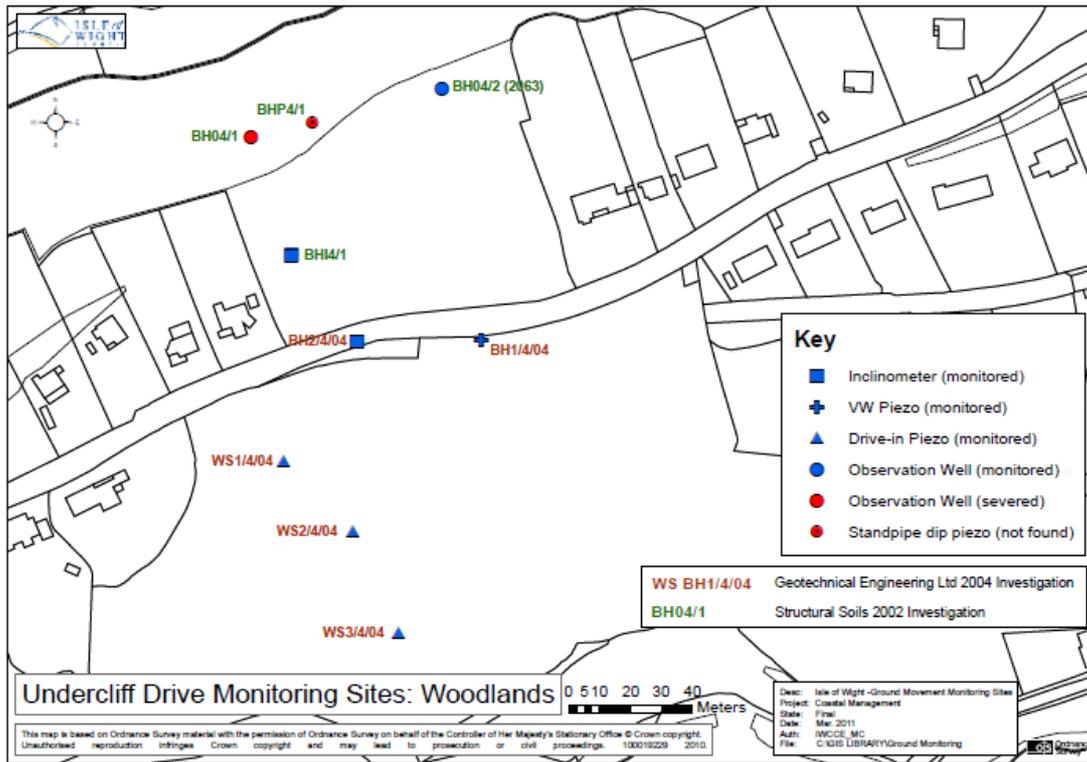
A location of the available monitoring points is shown in Figure 7, which comprise piezometers installed at a range of depths to monitor groundwater, and inclinometers to 50 metres depth to measure ground movement.

Figure 7 Monitoring locations, Undercliff Drive Site 9 - Woodlands

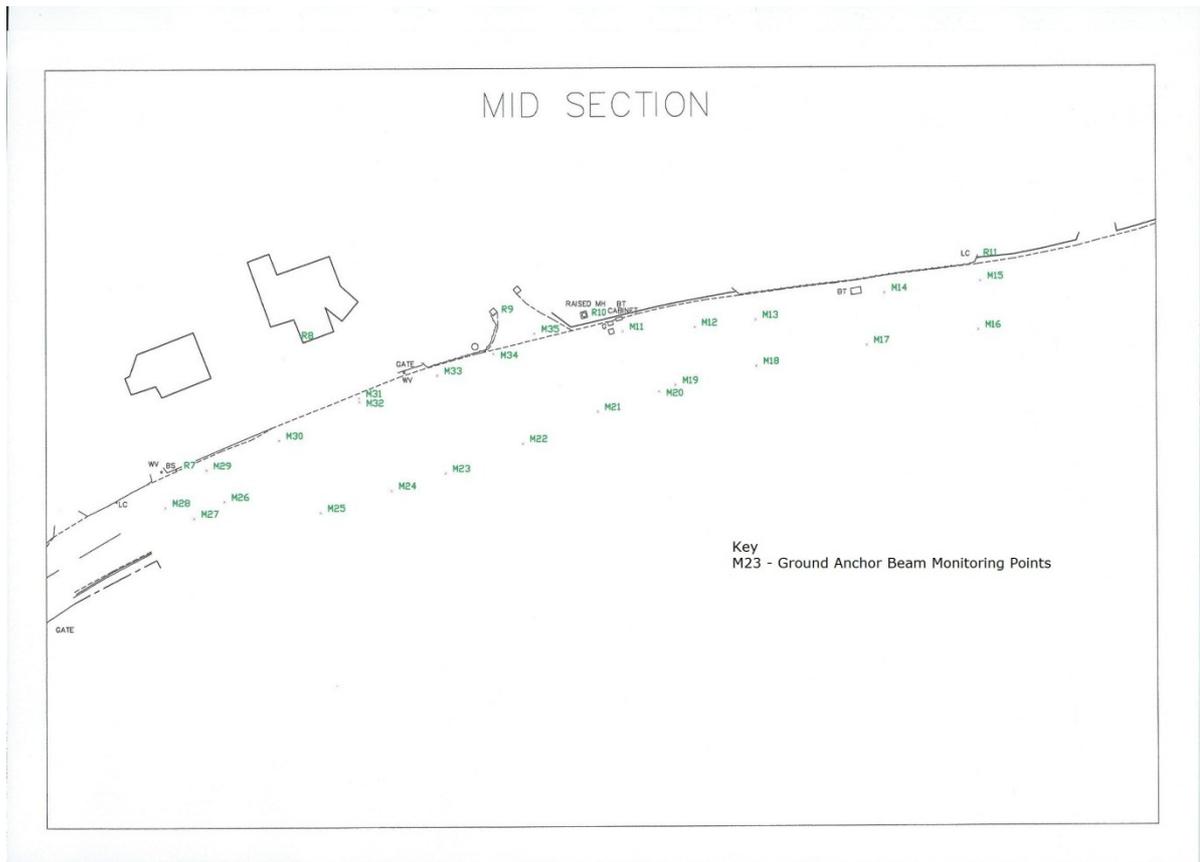
Figure 8 Ground anchor beam monitoring points

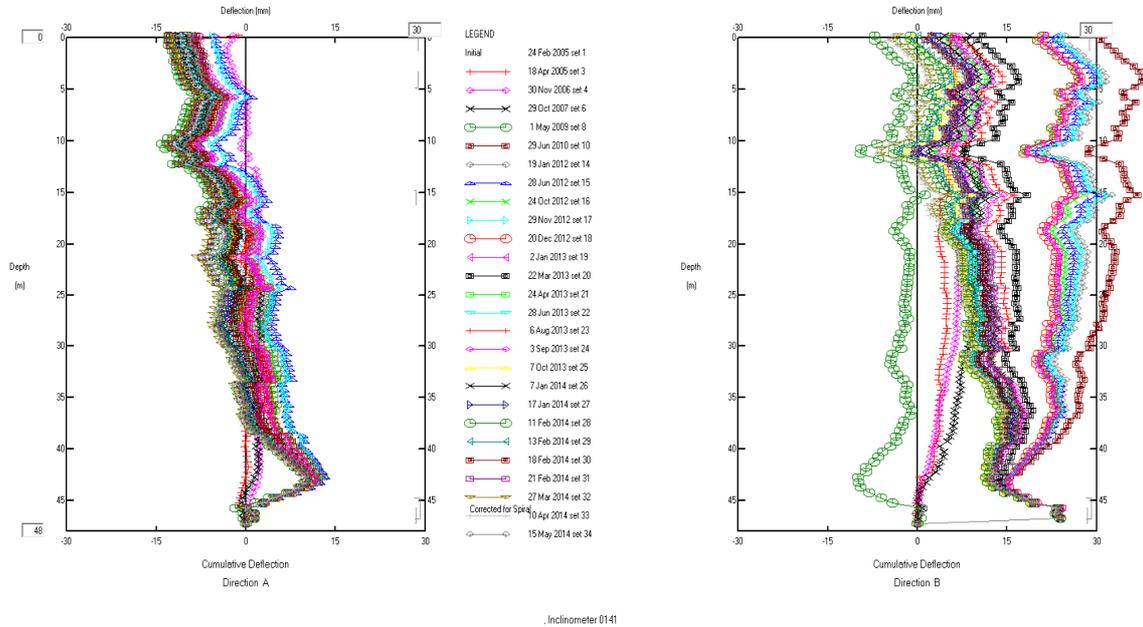
Appendix B- 6 Inclinator I/4 - cumulative deflection plots

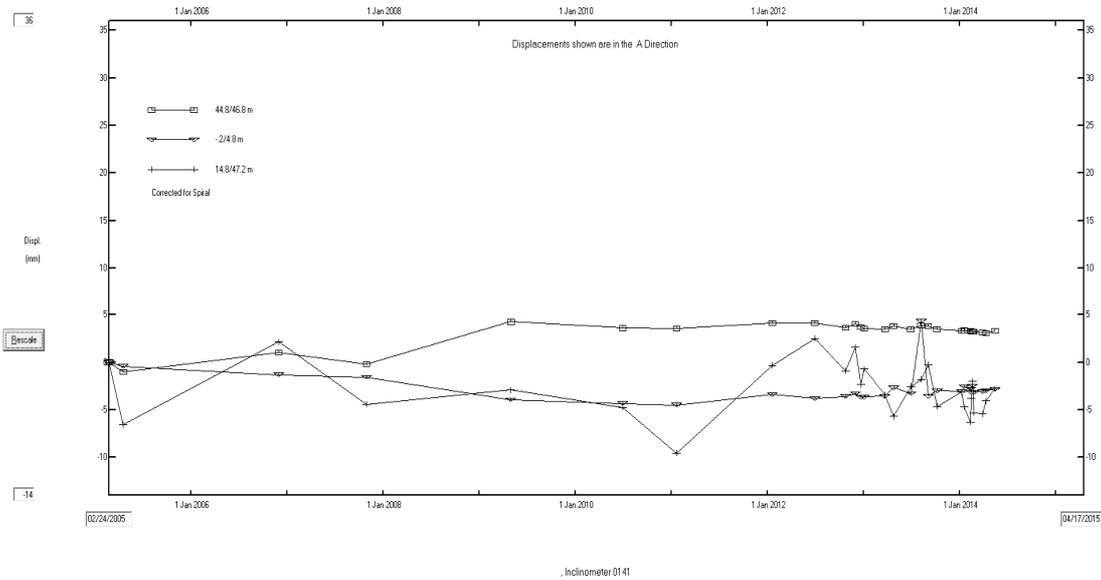
### Appendix B- 7 Inclinator I/4 - rate of displacement plots

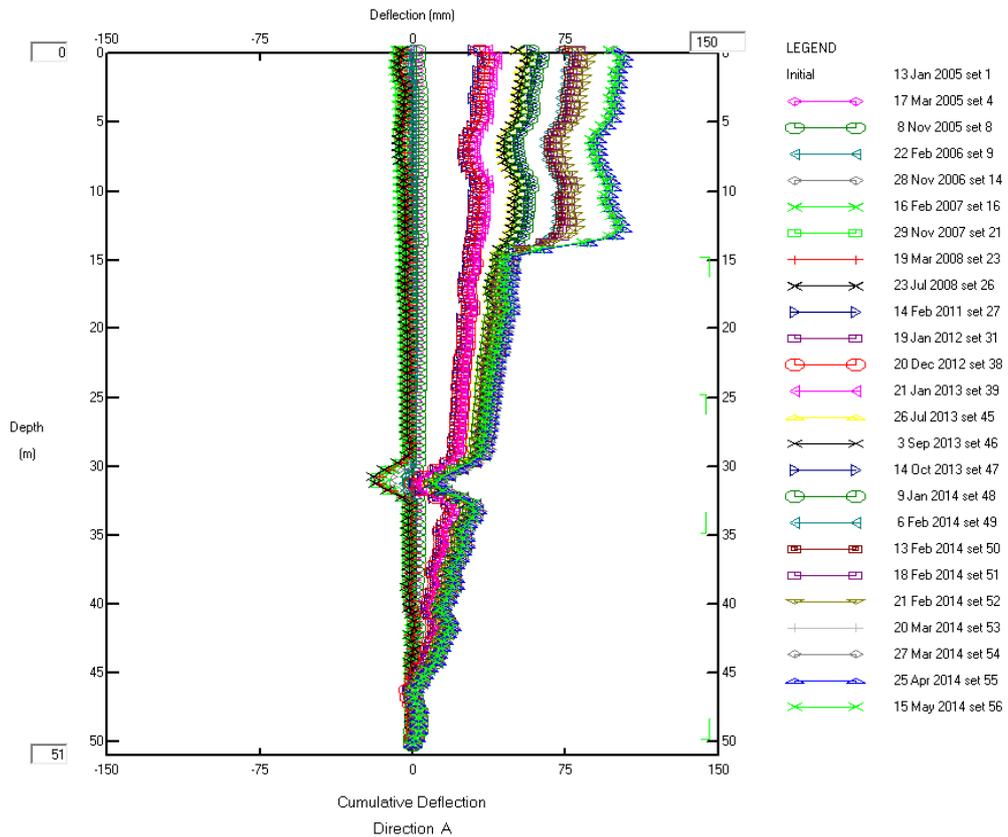
### Appendix B- 8 Inclinator 4304 Cumulative Displacement Plot

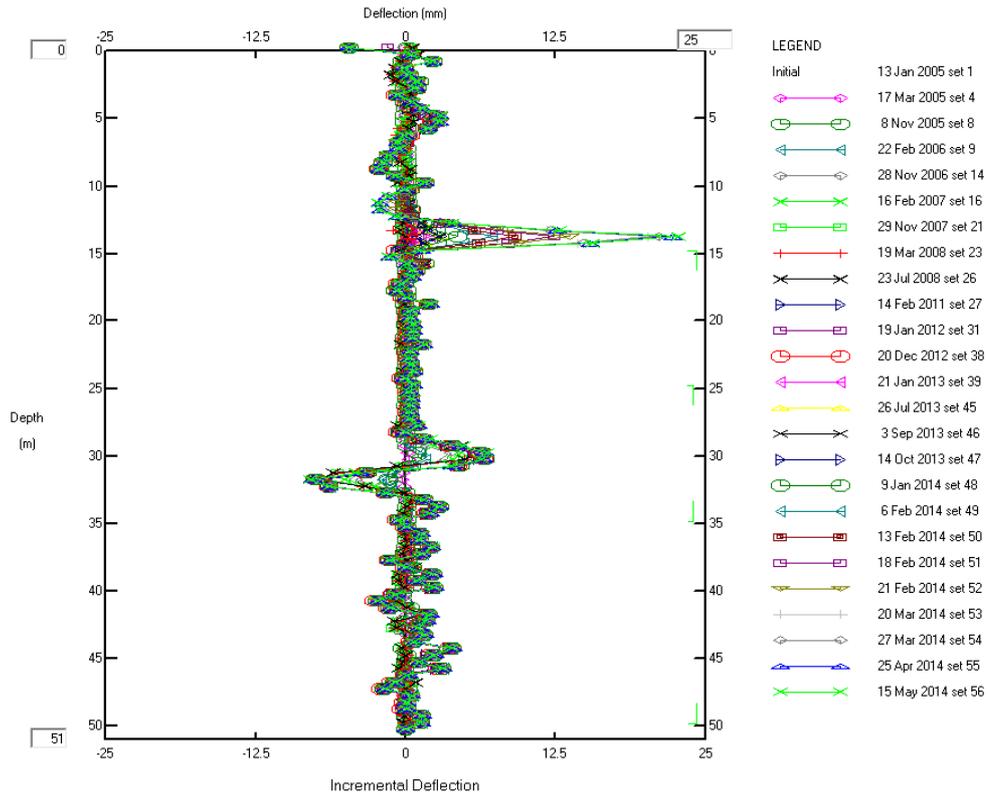
**Appendix B- 9 Inclinometer 4304 Incremental Plot**

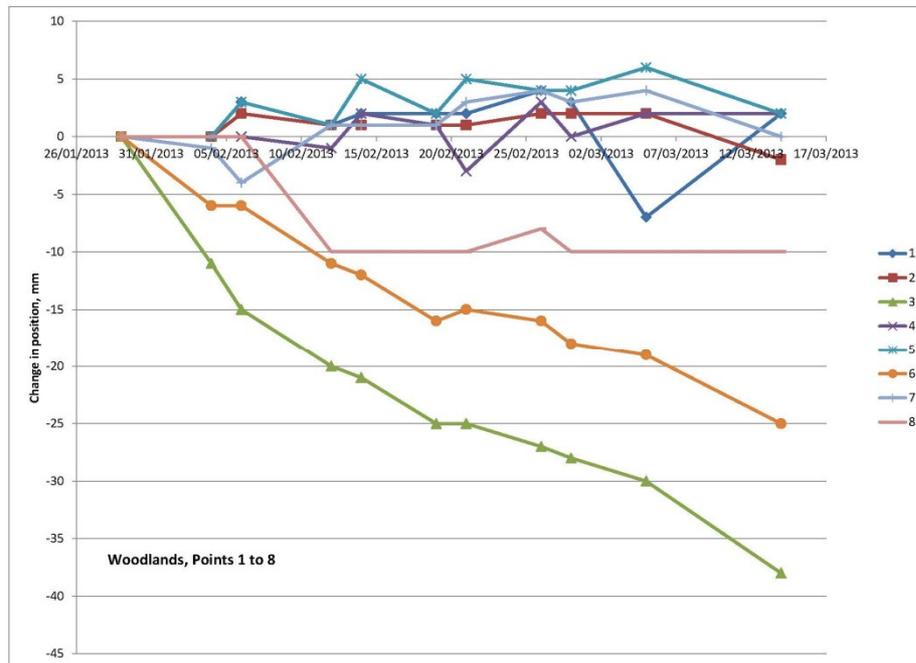
**Appendix B- 11 Surface Monitoring Points Established 2012/13 event**

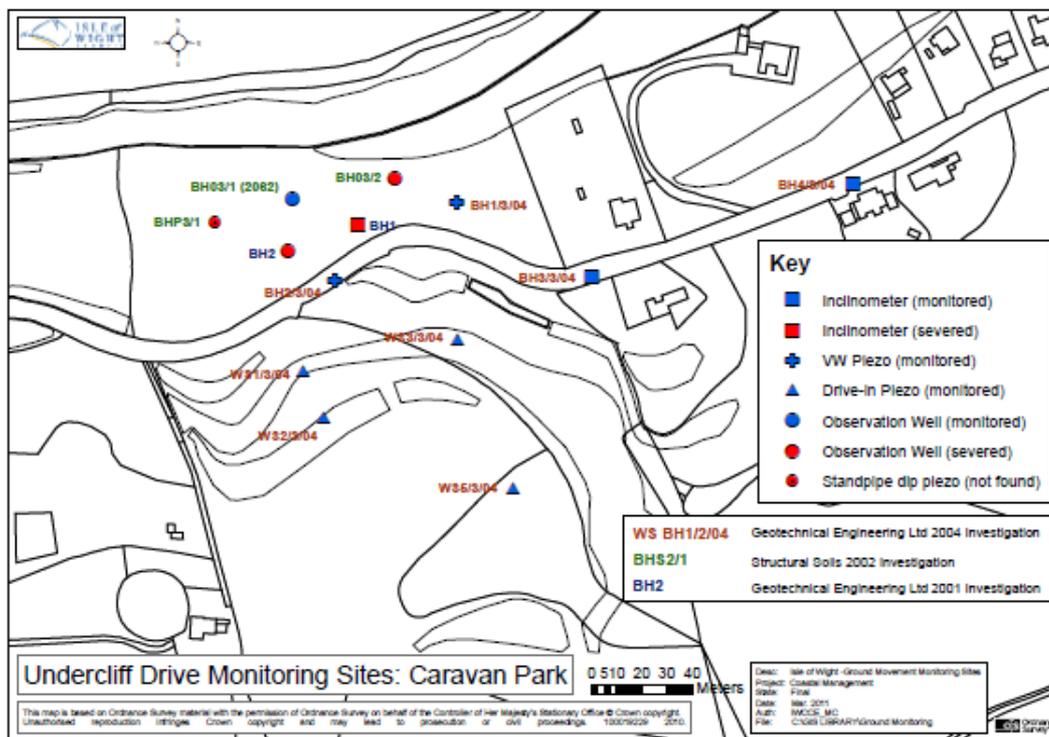
A location of the available monitoring points is shown in Figure 3, which comprise piezometers installed at a range of depths to monitor groundwater, and inclinometers to 50 metres depth to measure ground movement.

Figure 3 Undercliff Drive Site 10 Monitoring Location Plan

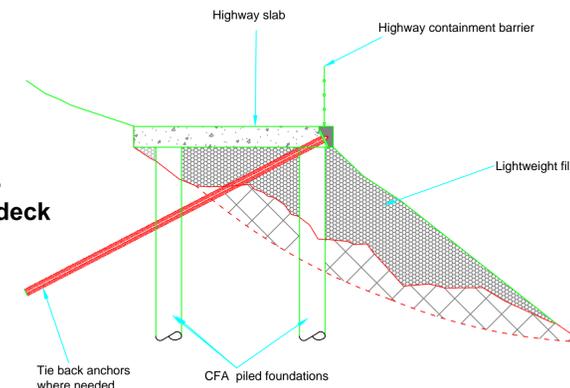
**Access Option 3**  
Pile supported road deck

Reduced risk of geological failure but still not complete removal of risk	
			Removal of slipped material required, temp works/monitoring needed to reduce risk of re-activation of slip	
3	Pile supported road deck	Provide long term solution which is resistant to increased range of geological failures	Significant temporary works required for construction access	£12m - £20m
		Reduced scope of maintenance required	Will require cosmetic measures to bring in keeping with local environment	
		Can be designed to provide long term stabilisation for deep slips but this will	Disturbs sub-surface groundwater environment

have a cost implication		
			Potential for slope failure either side of the structure will need to be considered, potential need for non-piled stabilisation at either end of route	
			Long term monitoring required	
4	Up-slope face stabilised by bolting and netting	Provides longer term protection for road and properties	Return visits will be required to stabilise emerging failures	£200k - £500k
		Reduced quality route pavement can be used	Access for works will be difficult, almost certainly roped access	
		Route independent of overall geological failure mechanism	Long term maintenance of rock slope vegetation will be required	
4	Establish rock fall protection structure	Provides long term protection with no upslope measure needed	Rockfalls will still occur therefore continuing property risk	£300k - £500k
		Route independent of overall geological failure mechanism	Protection structure will have a visual impact

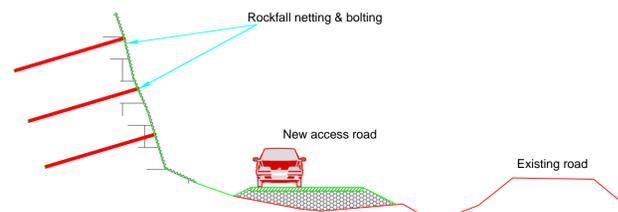
**Access Option 4**  
Up-slope face stabilised by bolting and netting

4	Up-slope face stabilised by bolting and netting	Provides longer term protection for road and properties Reduced quality route pavement can be used Route independent of overall geological failure mechanism	Return visits will be required to stabilise emerging failures Access for works will be difficult, almost certainly roped access Long term maintenance of rock slope vegetation will be required	
4	Establish rock fall protection structure	Provides long term protection with no upslope measure needed Route independent of overall geological failure mechanism	Rockfalls will still occur therefore continuing property risk Protection structure will have a visual impact Protection structure will require regular inspection	
5	Temporary Road at Niton End of Failure	Low Cost	Short Life solution, will require further works in the near future

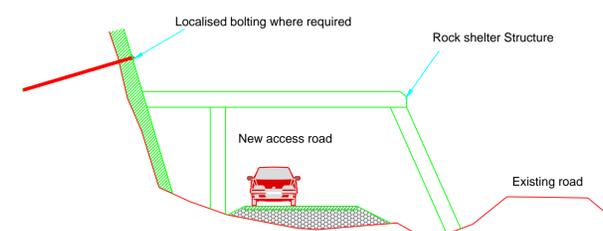
**Access Option 4**  
Rock fall protection structure

Protection structure will require regular inspection	
5	Temporary Road at Niton End of Failure	Low Cost	Short Life solution, will require further works in the near future	Less than £100k but will require further expenditure in future
		Low environmental impact	Ongoing monitoring of temporary road and slipped zone will be required	
6	Permanent Road Closure	Low cost and environmental impact	No vehicular or footpath access to properties between 'Woodlands' and Undercliff Glen Caravan Park'	Less than £100k
